Upper Los Angeles River Watershed Strategic Implementation Plan for *Arundo donax* Treatment and Eradication

PREPARED FOR
Council for Watershed Health
Los Angeles, California

PREPARED BY
Stillwater Sciences
555 W 5th Street, 35th Floor
Los Angeles, California 90013

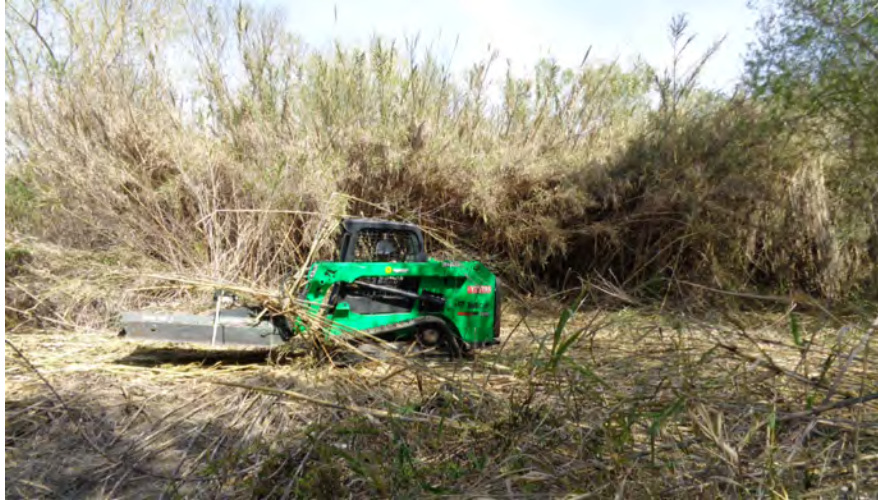
Figure 2-1. Arundo mowing in Little Tujunga Wash, courtesy of Bill Neill (Appendix C).

Small stands of Arundo, or areas of Arundo infestation in which herbicide application is not possible, may be treated by mechanical means as described in Ditomaso et al. (2013). Small plants (less than 6') can effectively be removed through pulling by hand or with small tools after a recent rain has loosened the soil. Larger stands may be eradicated by repeatedly chopping, cutting, or mowing shoots until the Arundo has exhausted its underground nutrient storage. Timing of removal should coincide with flowering, as underground nutrient storage is depleted during this time. In order to complete eradication, the entirety of the rhizome mass must be removed to avoid repeated infestation.

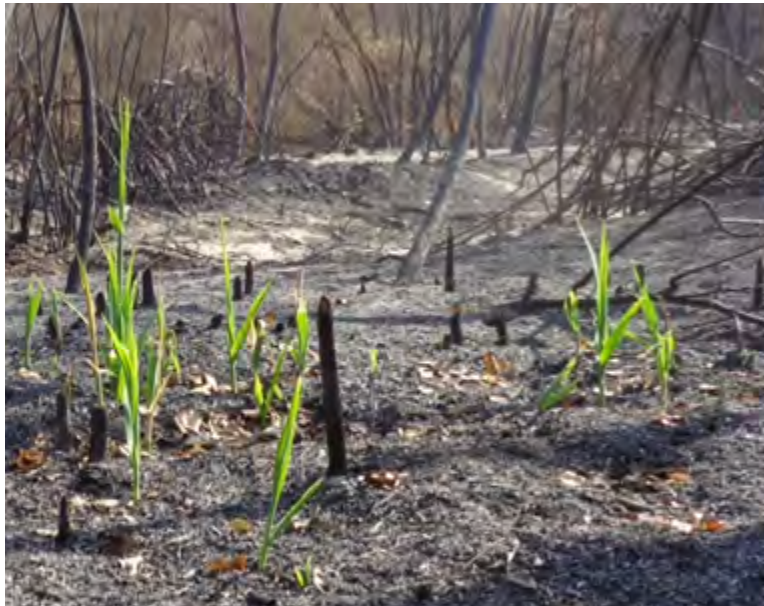
Figure 4-5. Post Creek Fire growth of Arundo in Hansen Dam, courtesy of Bill Neill.

The Creek Fire of December 2017 burned large portions of remaining Arundo stands within Hansen Dam and allowed access to previously inaccessible areas. Treatment post-fire was emphasized due to the lower effort level required treating recently burned areas (see Figure 4-5).

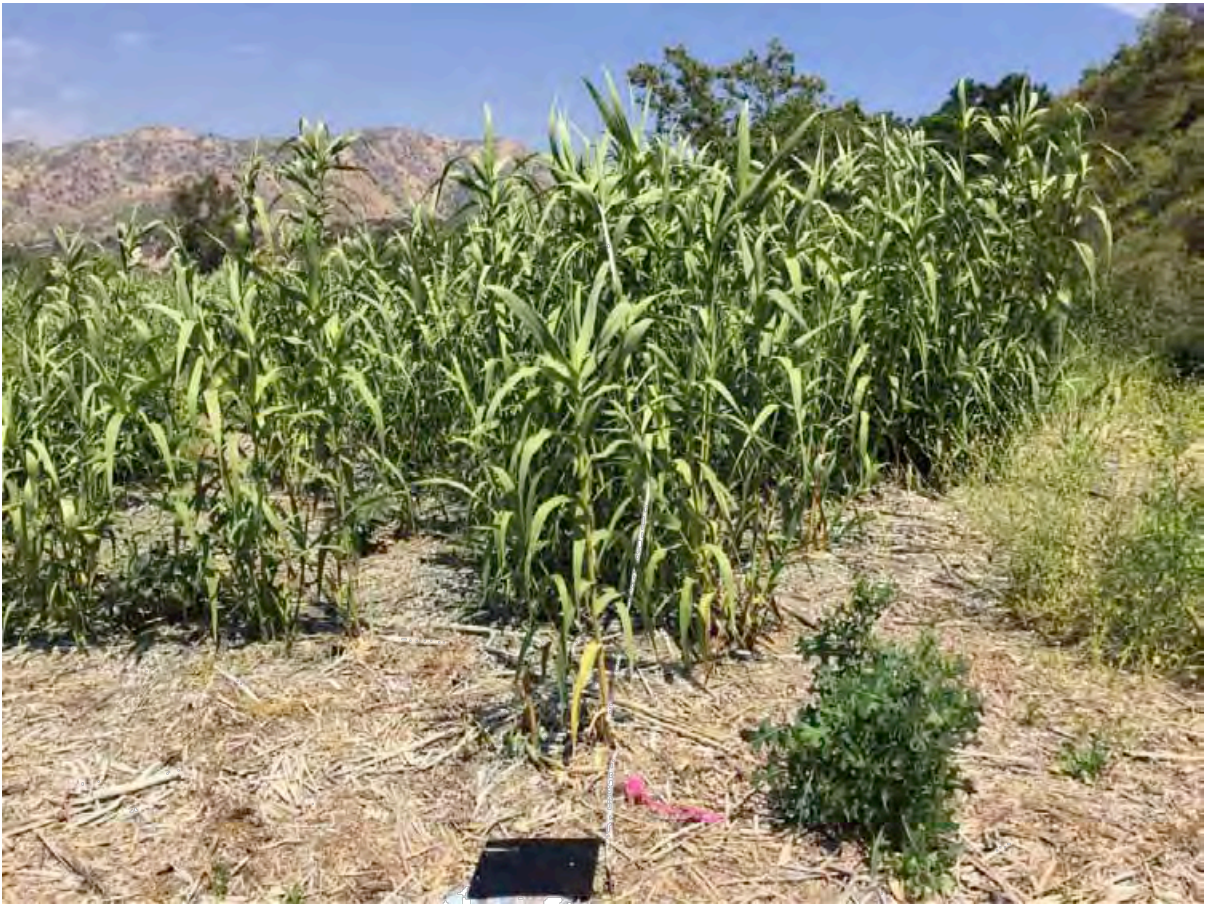
Transect 1: 5-30-2017 Base stake to end point.

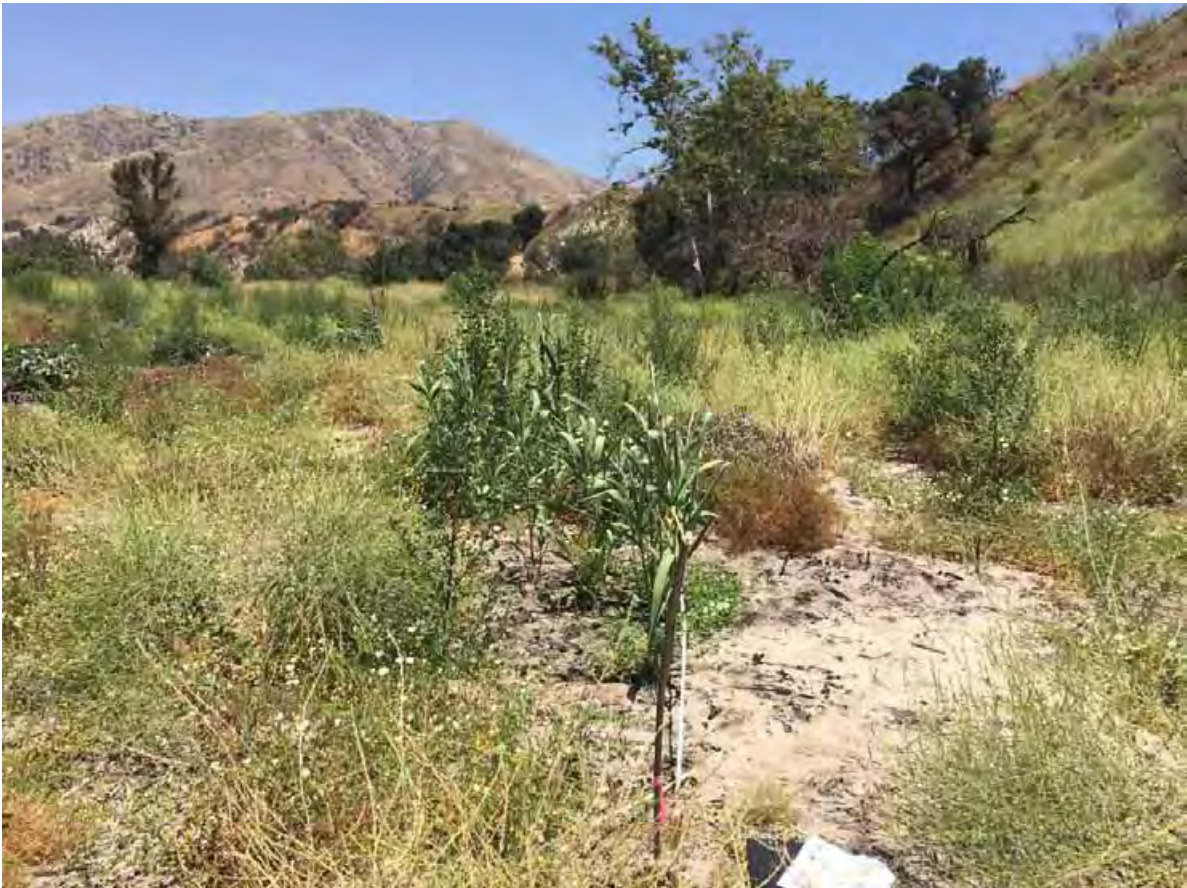
Transect 1: 6-15-2018 Base stake to end point.

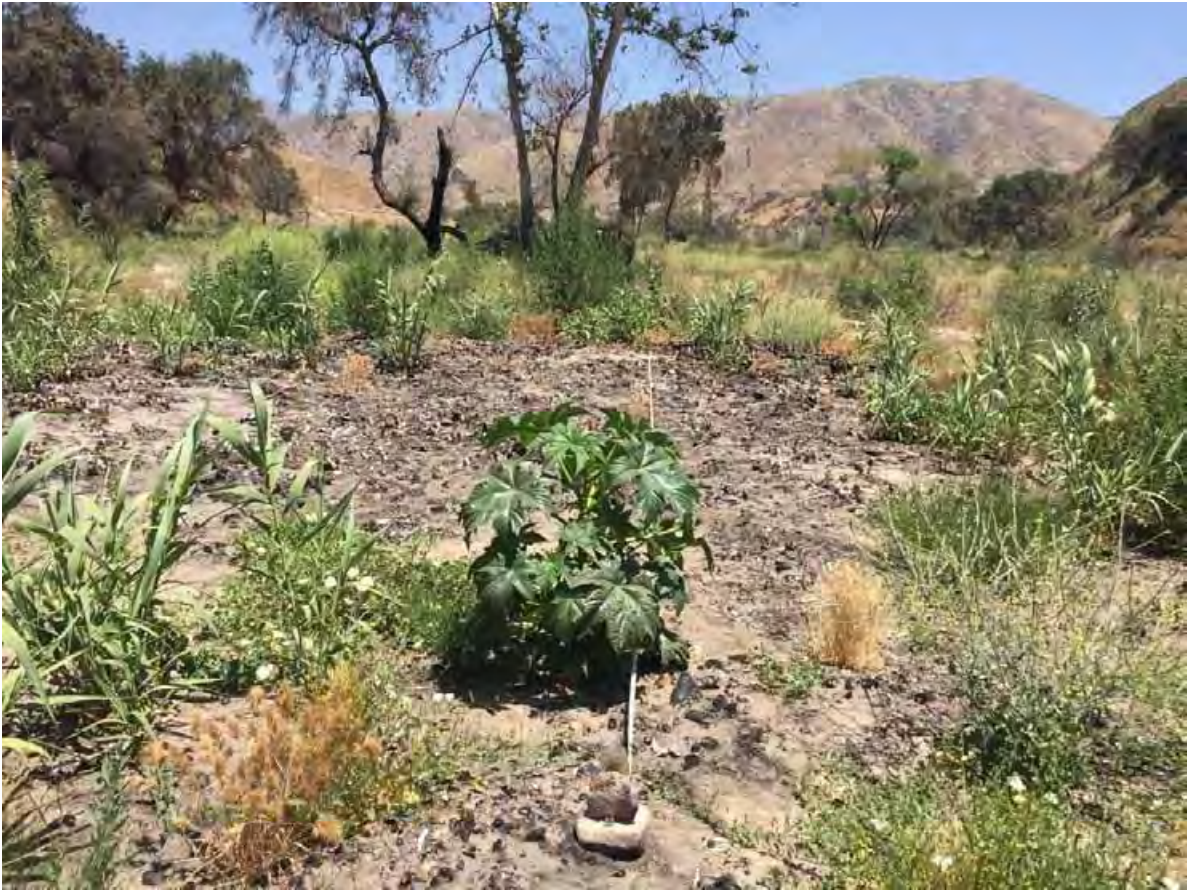
Transect 2: 6-15-2018 Base stake to end point.

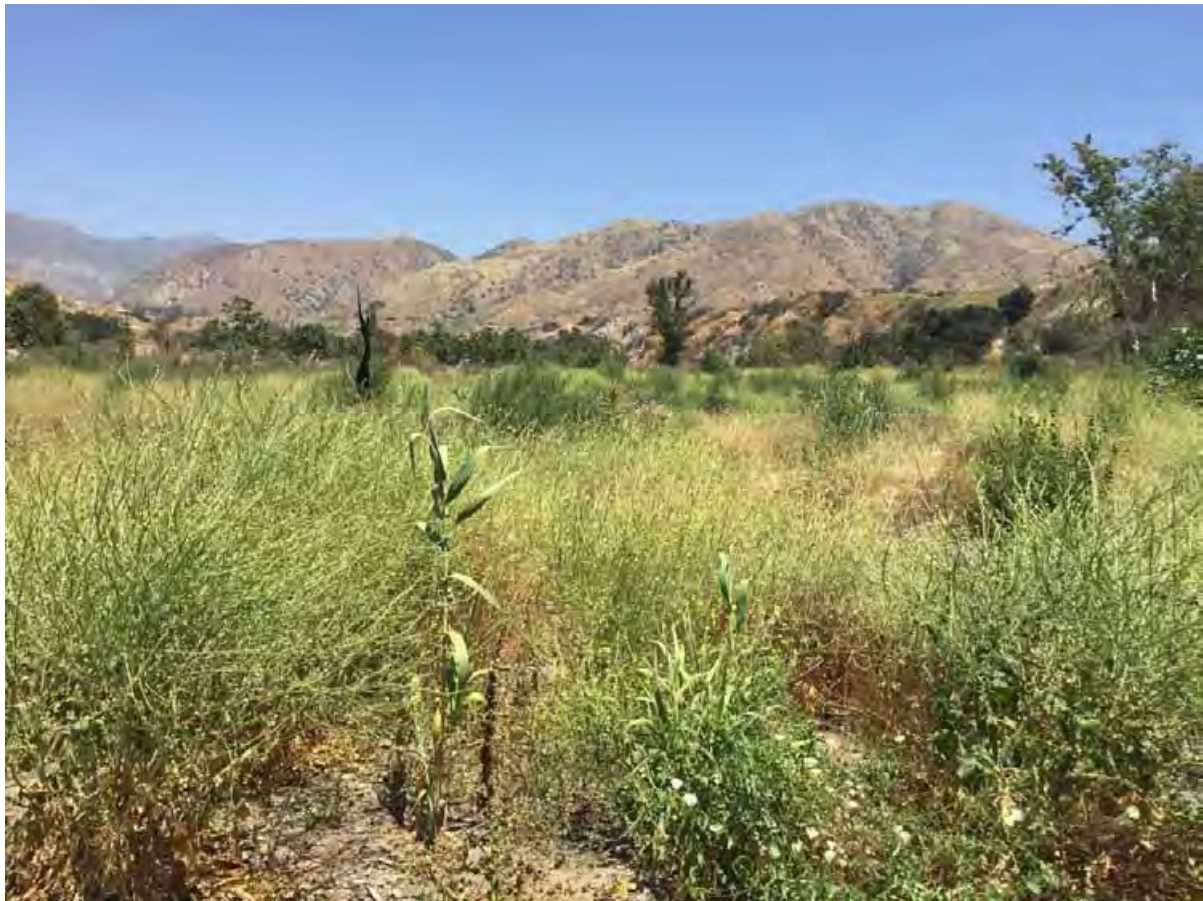
Photo point #1: Upper Middle Ranch, Little Tujunga: 2018-6-15 Scattered Arundo regrowth before second treatment, site burned Dec 2017.

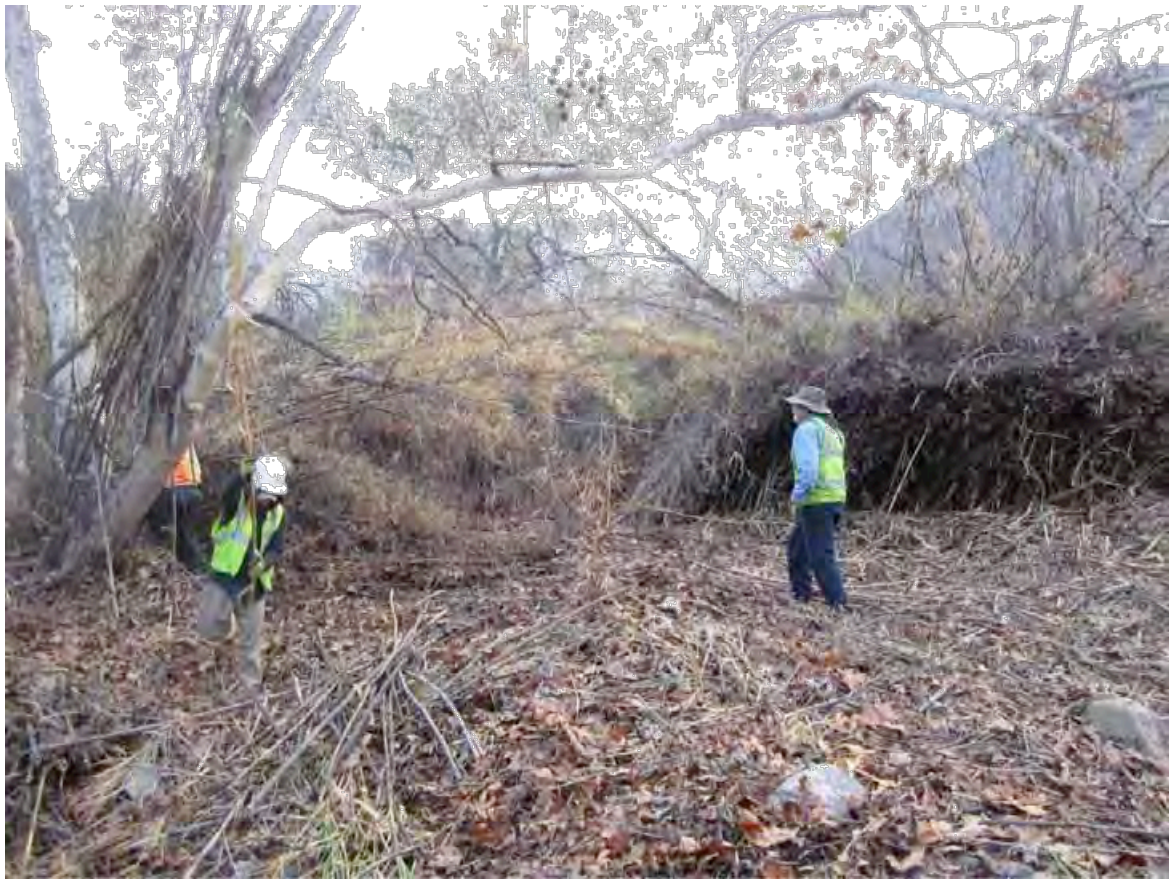
Photo point #2: Little Tujunga: 2016-11-1 Before cutting and chipping.

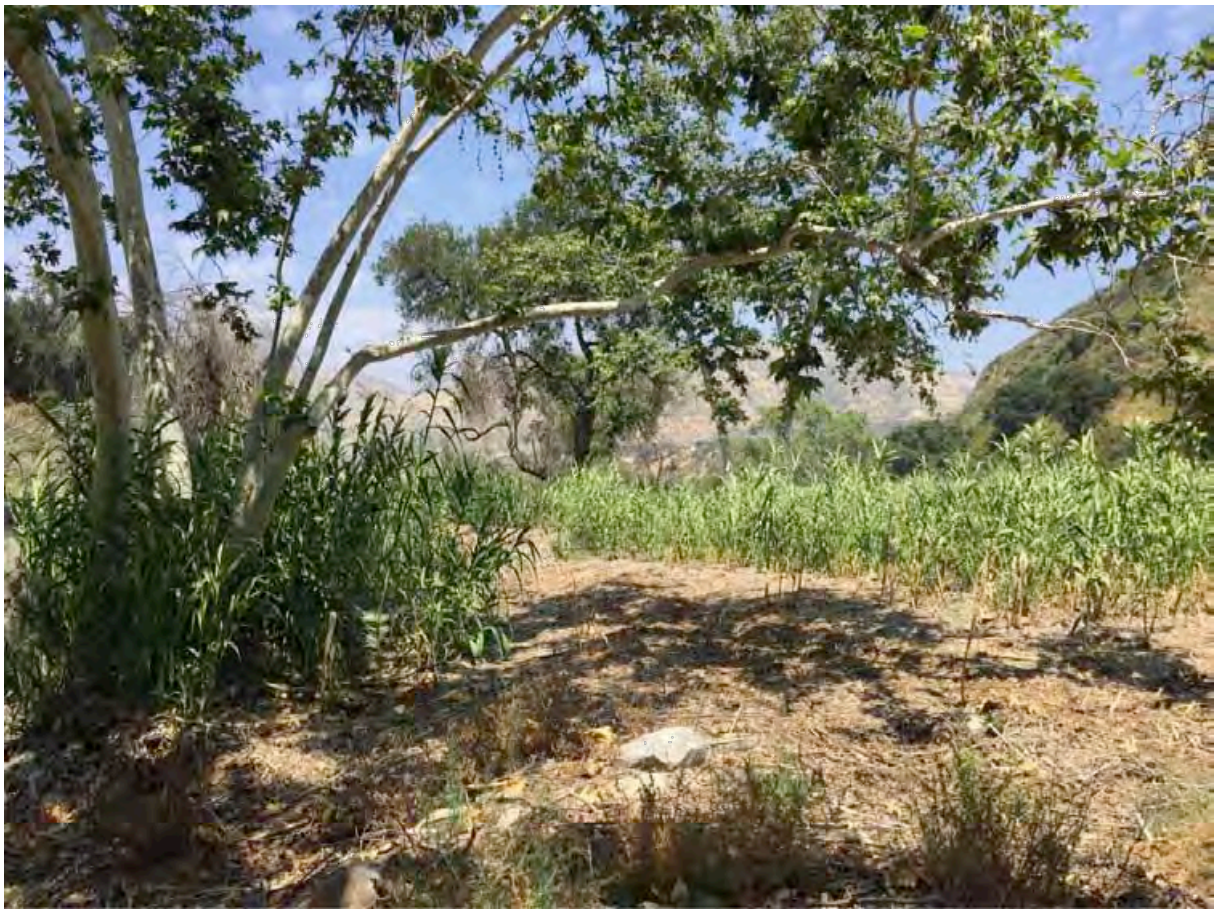
Photo point #2: Little Tujunga: 2017-5-30 Arundo re-growth before first treatment.

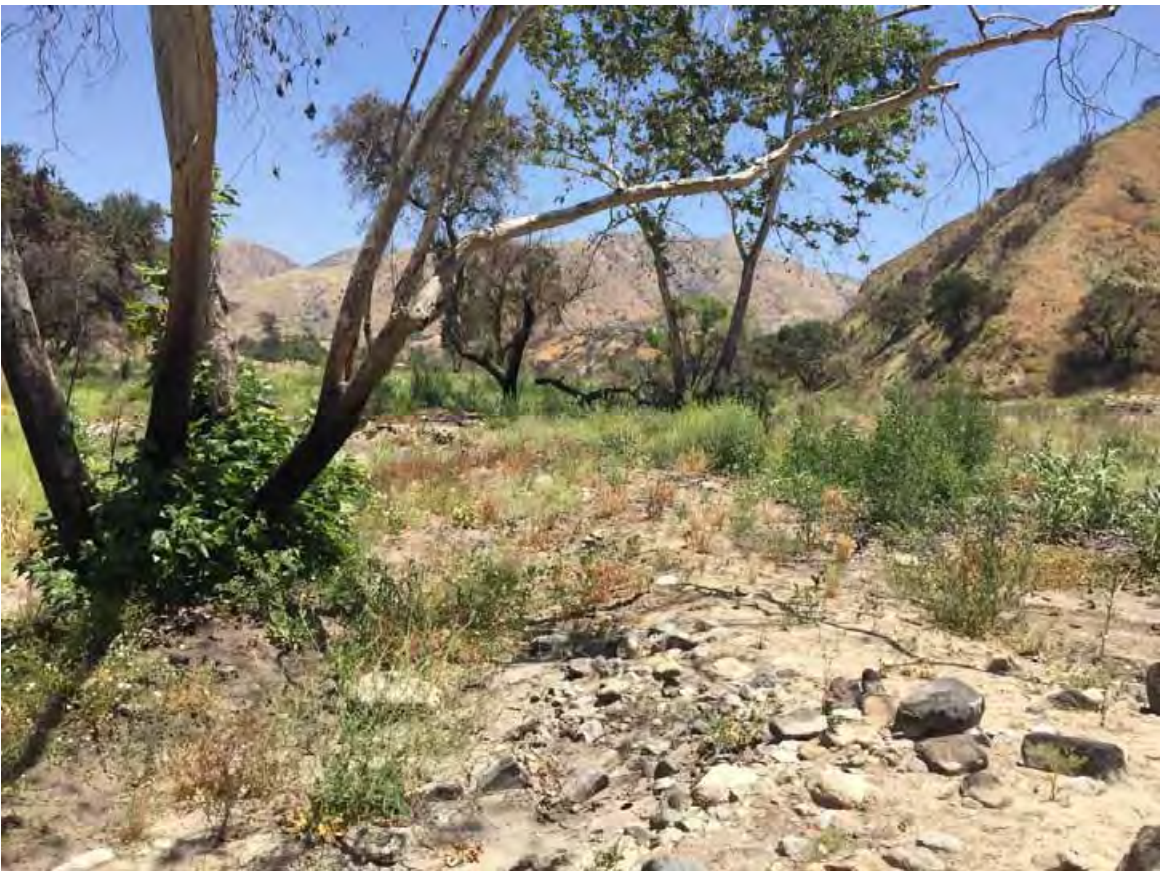
Photo point #2: Little Tujunga: 2018-6-15 Scattered regrowth before second treatment, site burned Dec 2017.

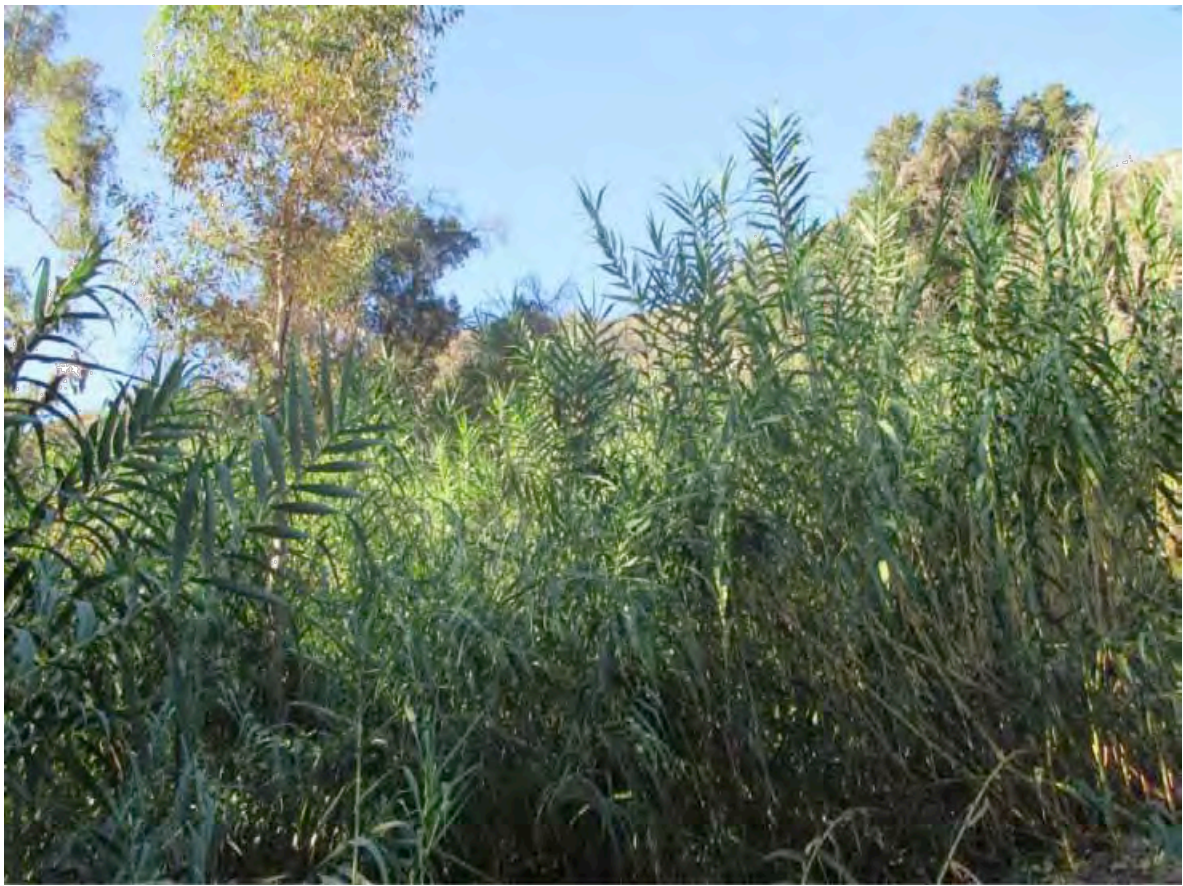
Photo point #3: Lower Middle Ranch, Little Tujunga: 2016-9-27 Arundo before cutting and chipping.

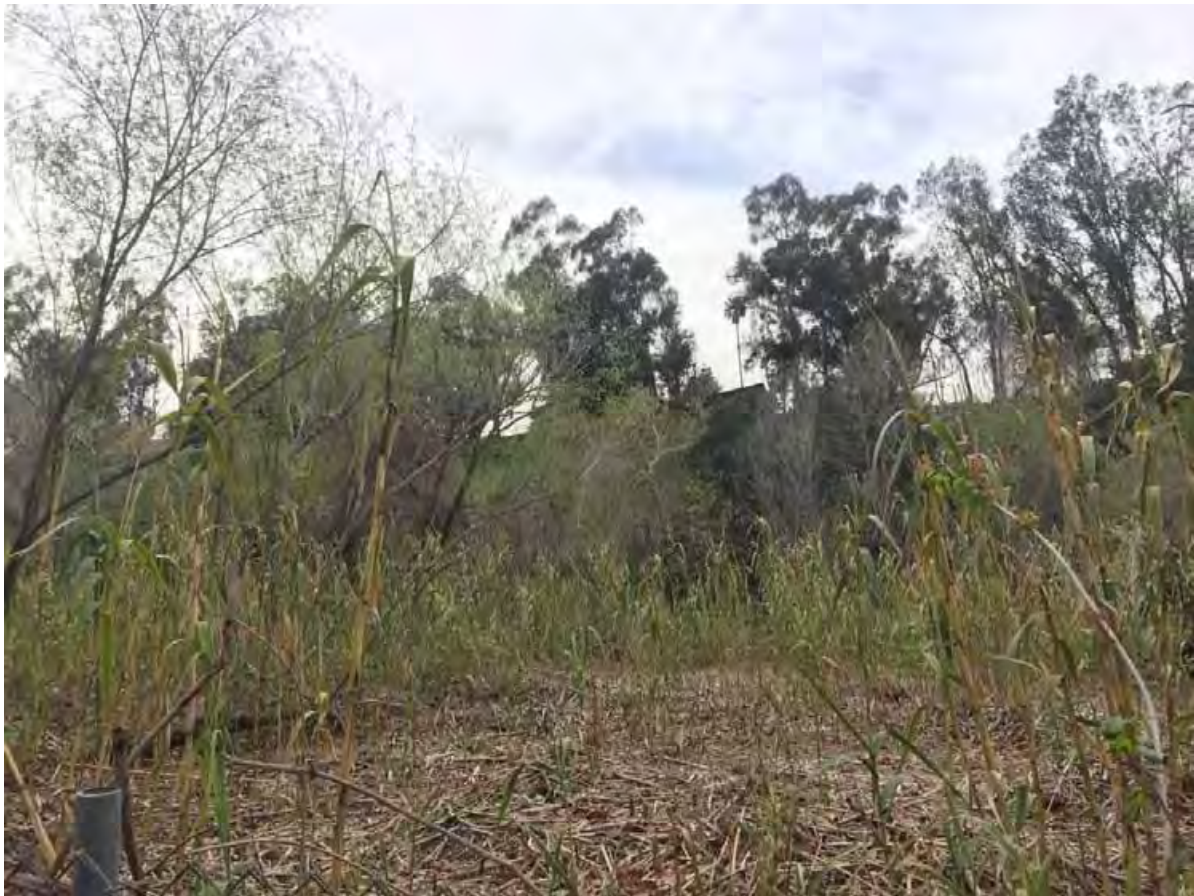
Photo point #3: Lower Middle Ranch, Little Tujunga: 2017-2-16 Arundo winter re-growth just after first treatment.

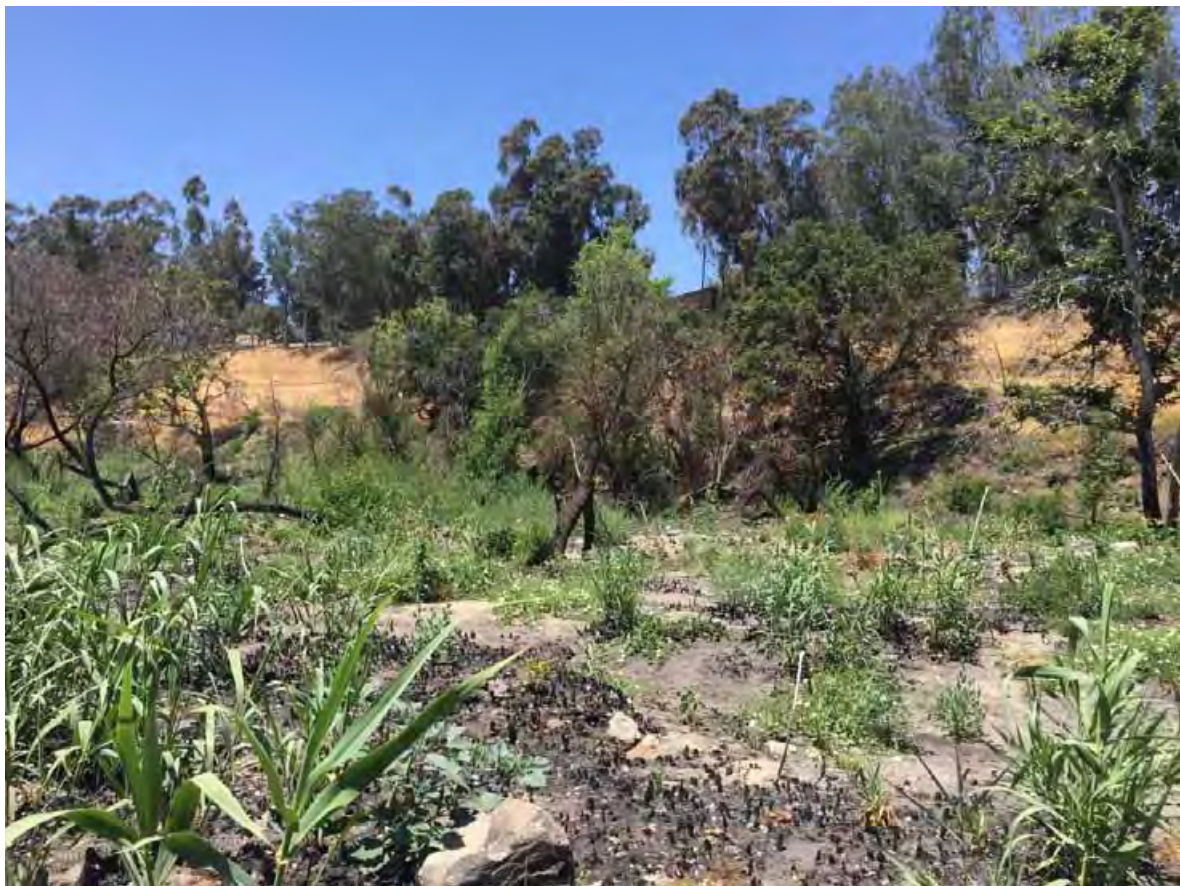
Photo point #3: Lower Middle Ranch, Little Tujunga: 2018-6-15 Scattered Arundo regrowth before second treatment, site burned Dec 2017.

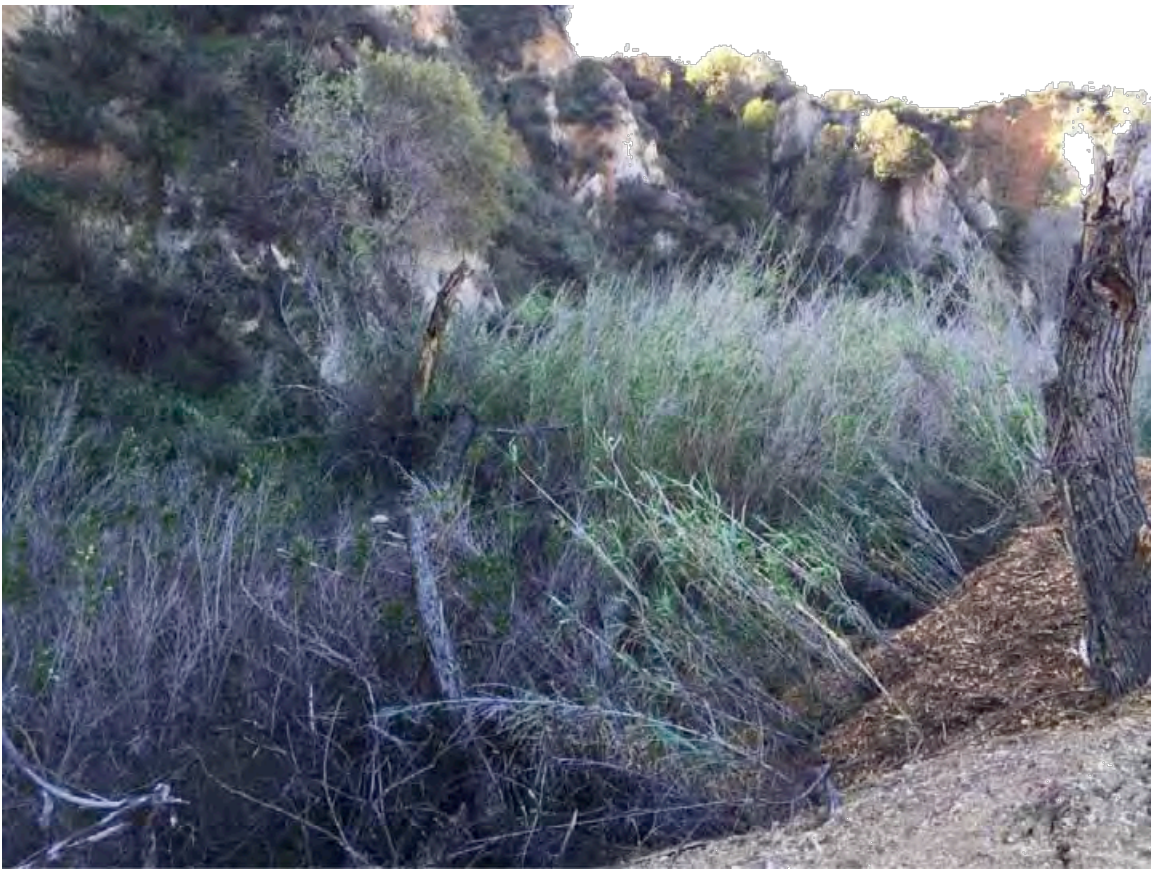
Photo point #4: Upper Little Tujunga: 2016-2-22 Arundo before cutting and chipping.

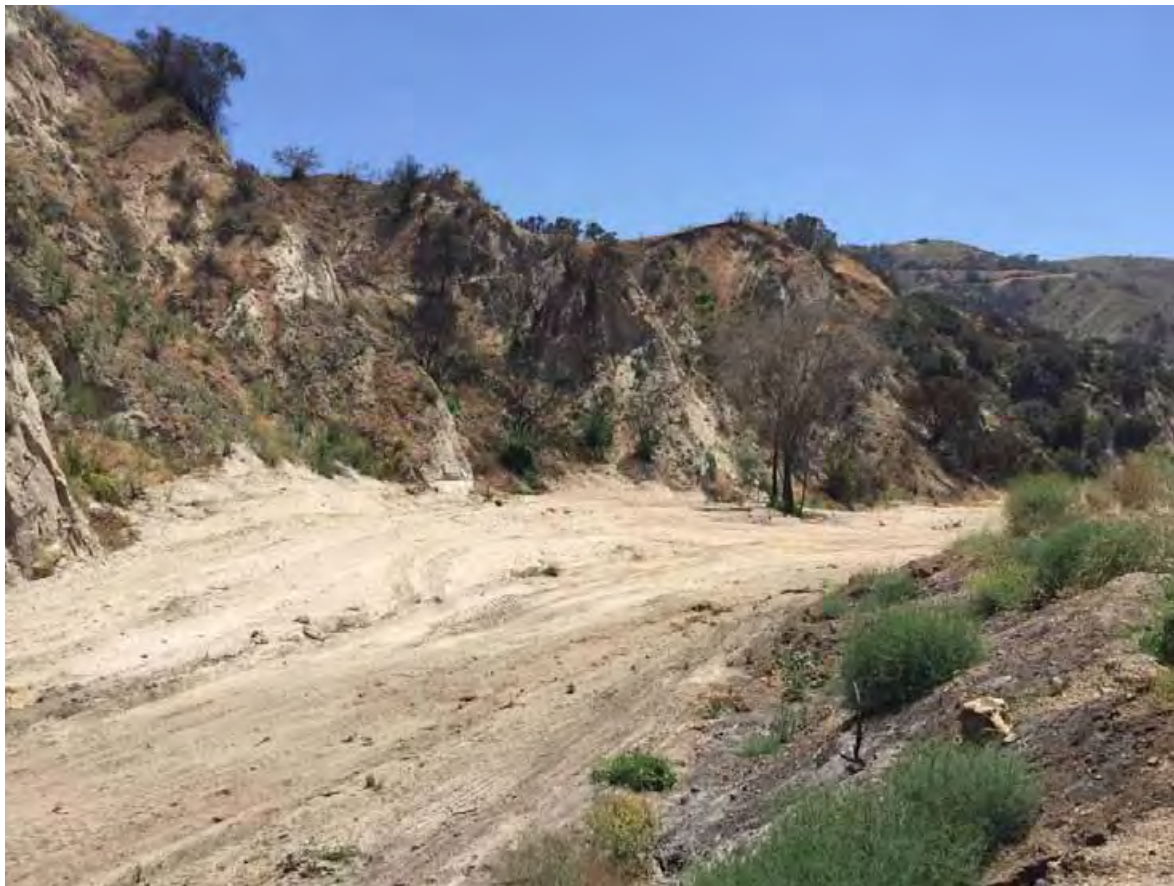
Photo point #4: Upper Little Tujunga: 2018-6-15 No Arundo regrowth before second treatment, site burned Dec 2017.

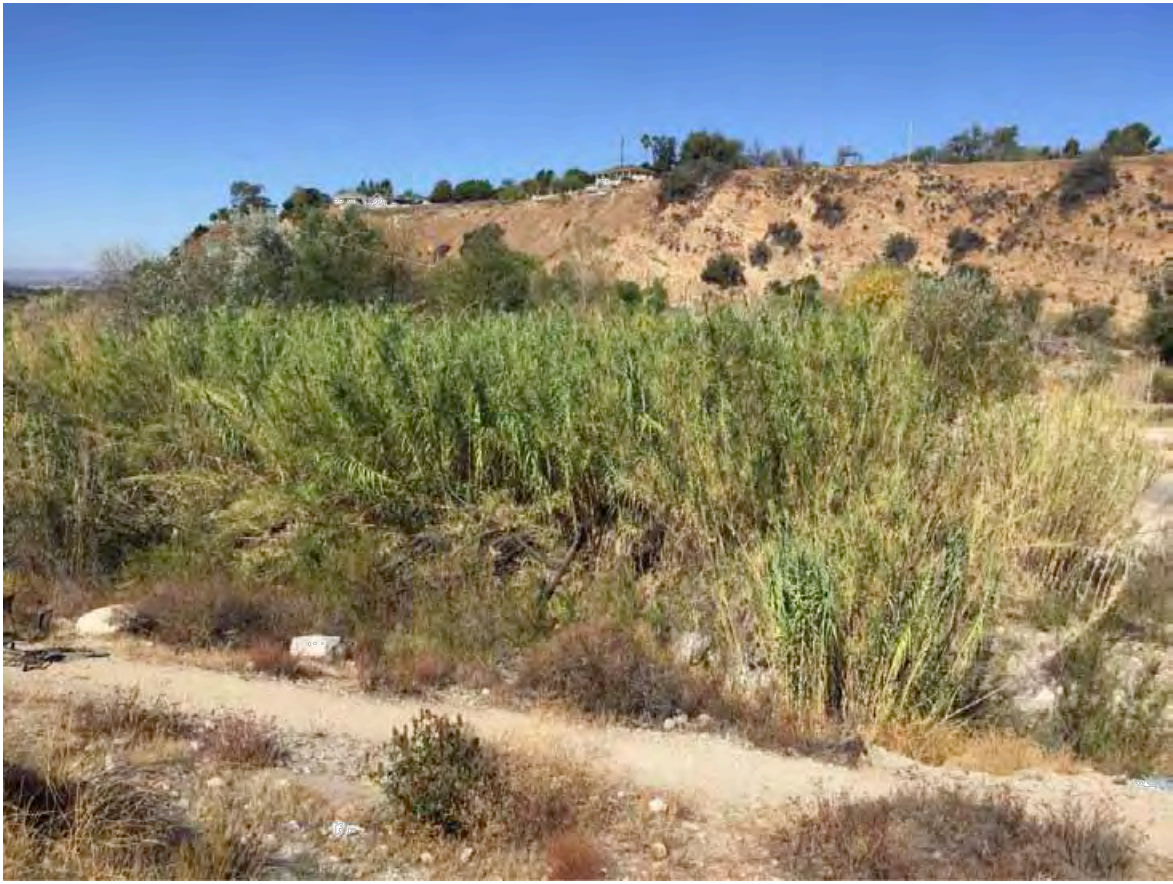
Photo point #5: Big Tujunga, Oro Vista: 2016-9-23 Arundo before cutting and chipping.

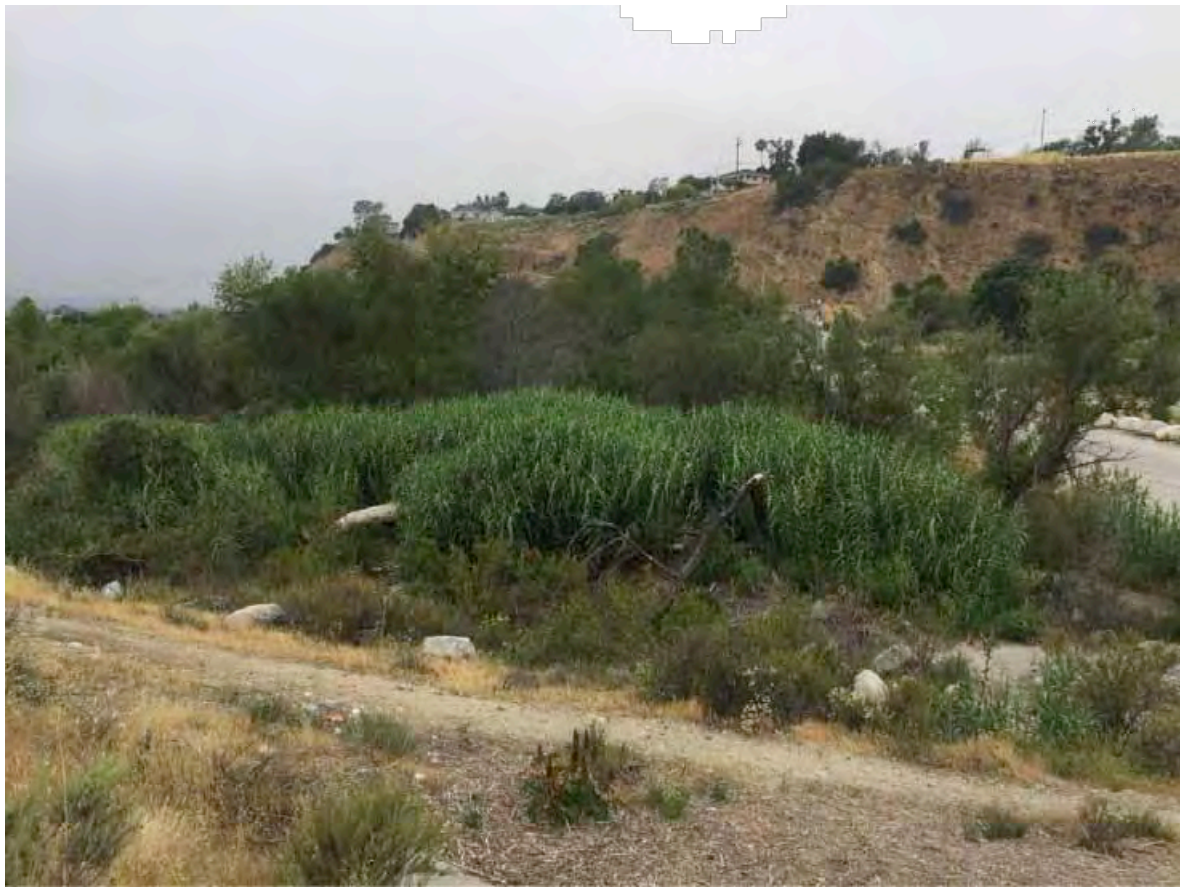
Photo point #5: Big Tujunga, Oro Vista: 201-5-30 Arundo re-growth before treatment.

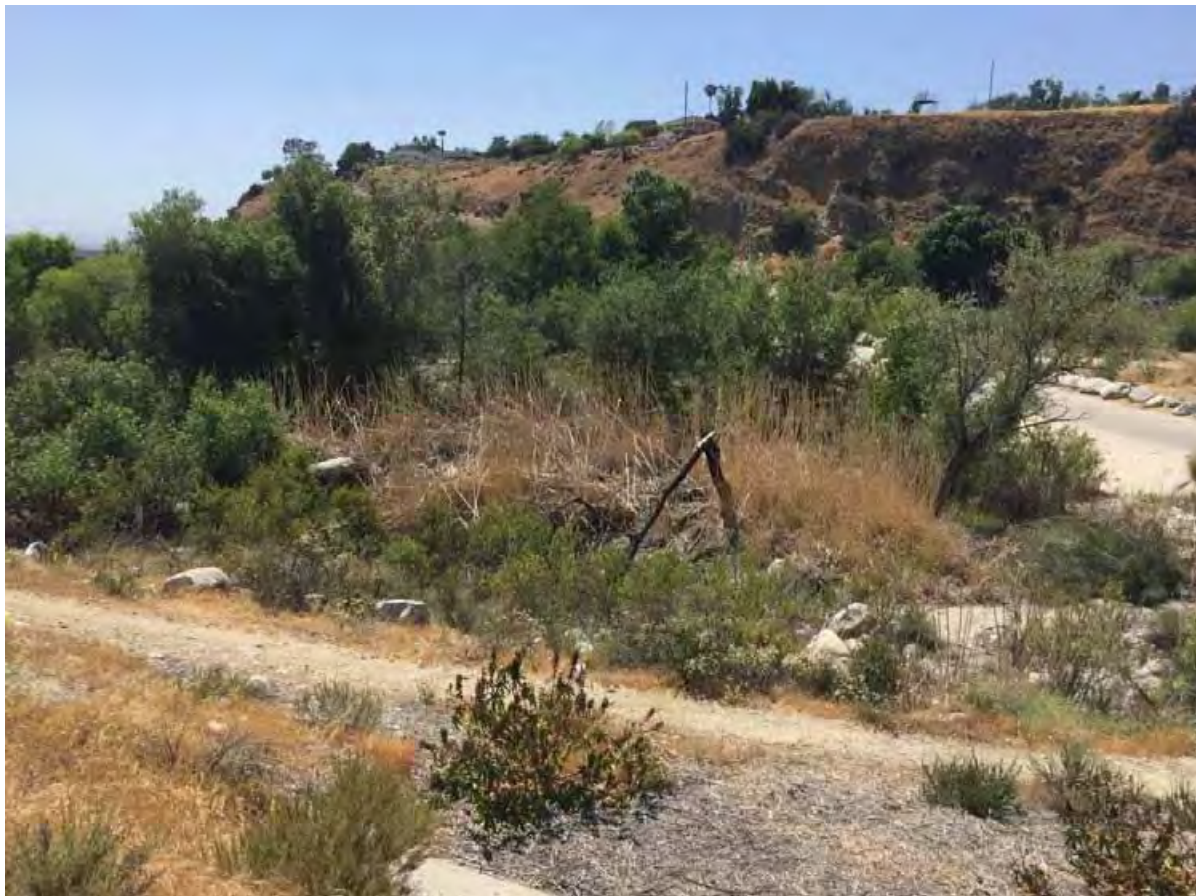
Photo point #5: Big Tujunga, Oro Vista: 2018-6-15 Minimal Arundo regrowth, second treatment will be in fall 2018.

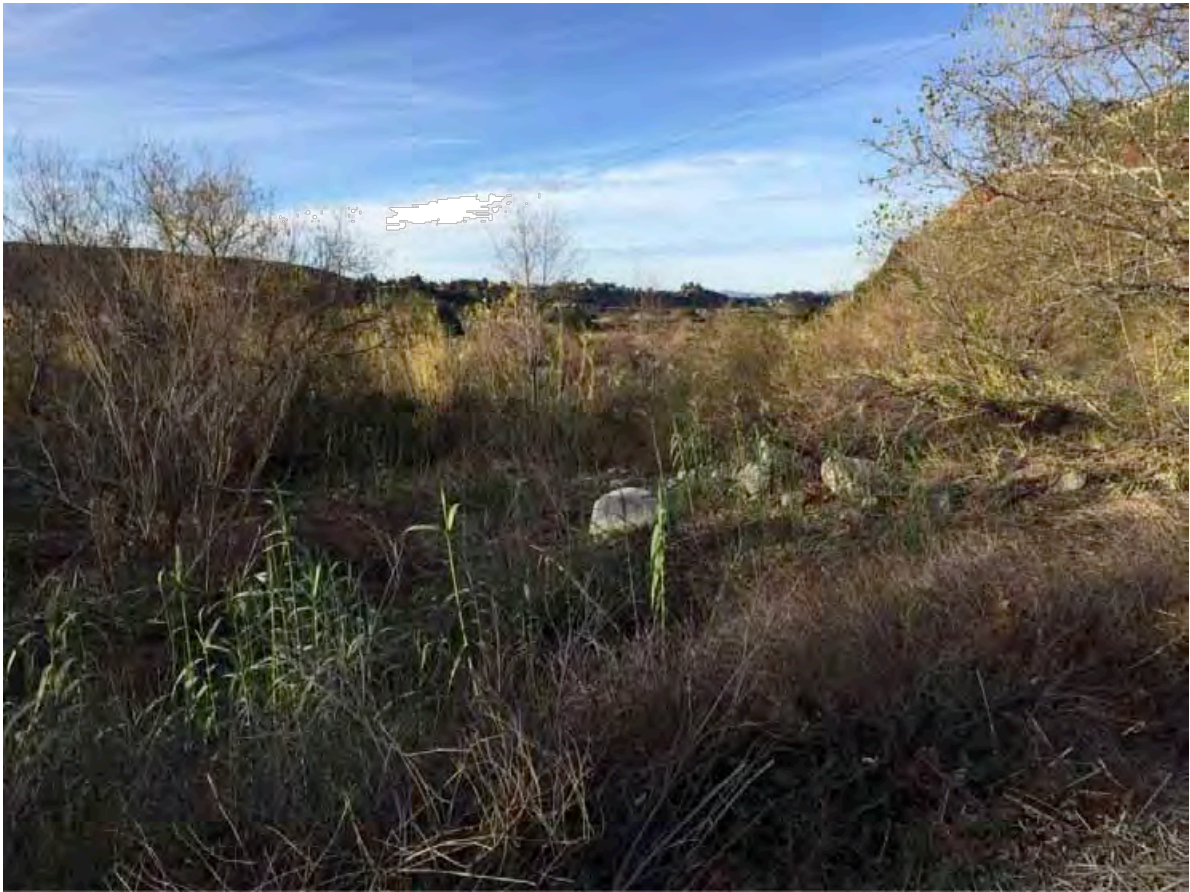
Photo point #6: Oro Vista Big Tujunga: 2017-1-17 Arundo winter re-growth and first treatment.

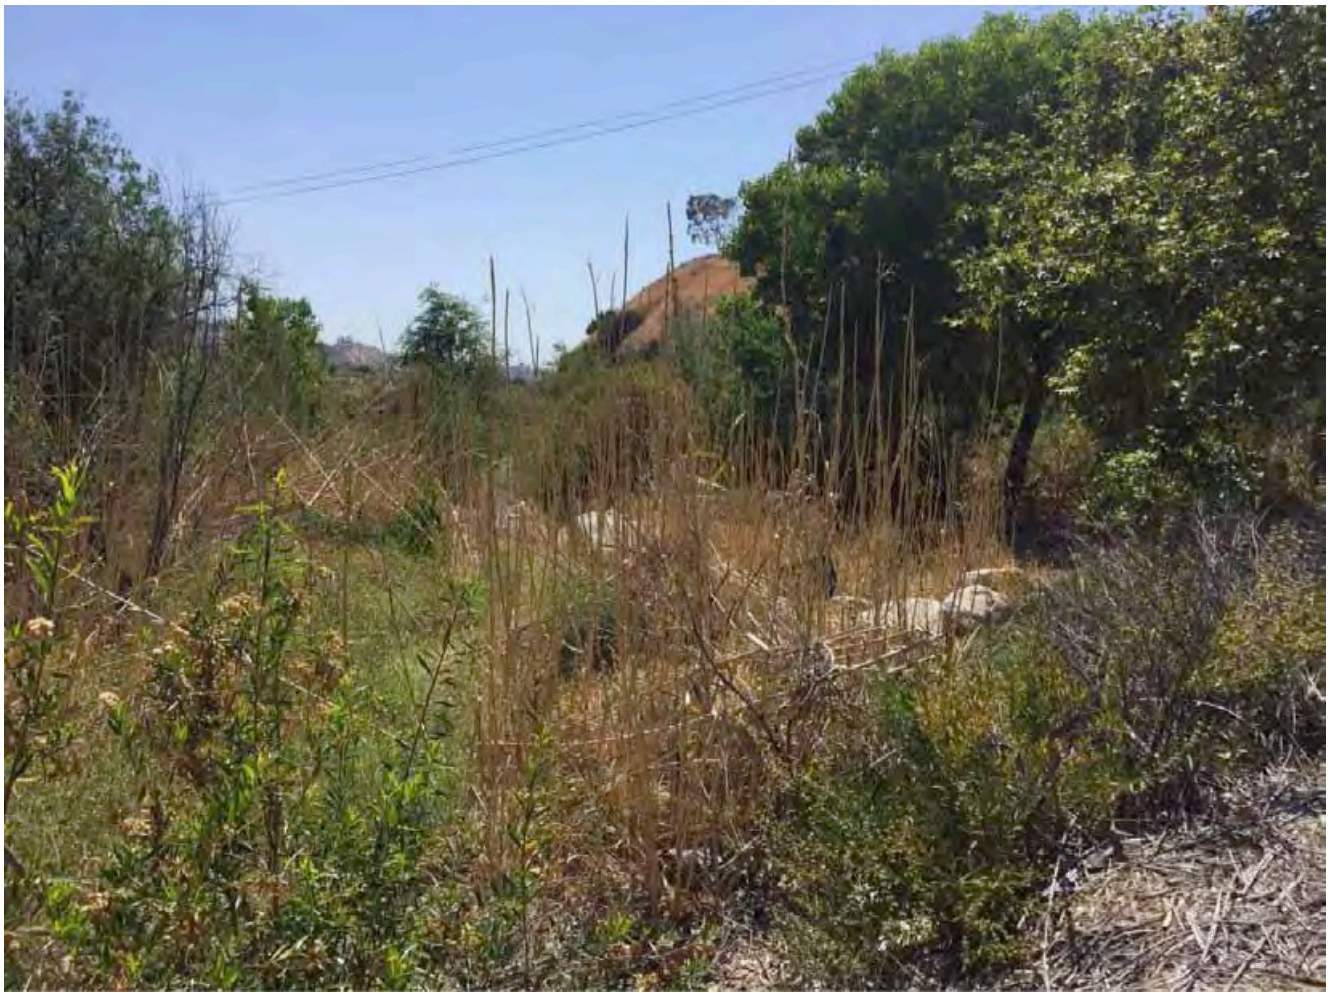
Photo point #6: Oro Vista Big Tujunga: 2018-6-15 Minimal Arundo regrowth, second treatment will be in fall 2018.

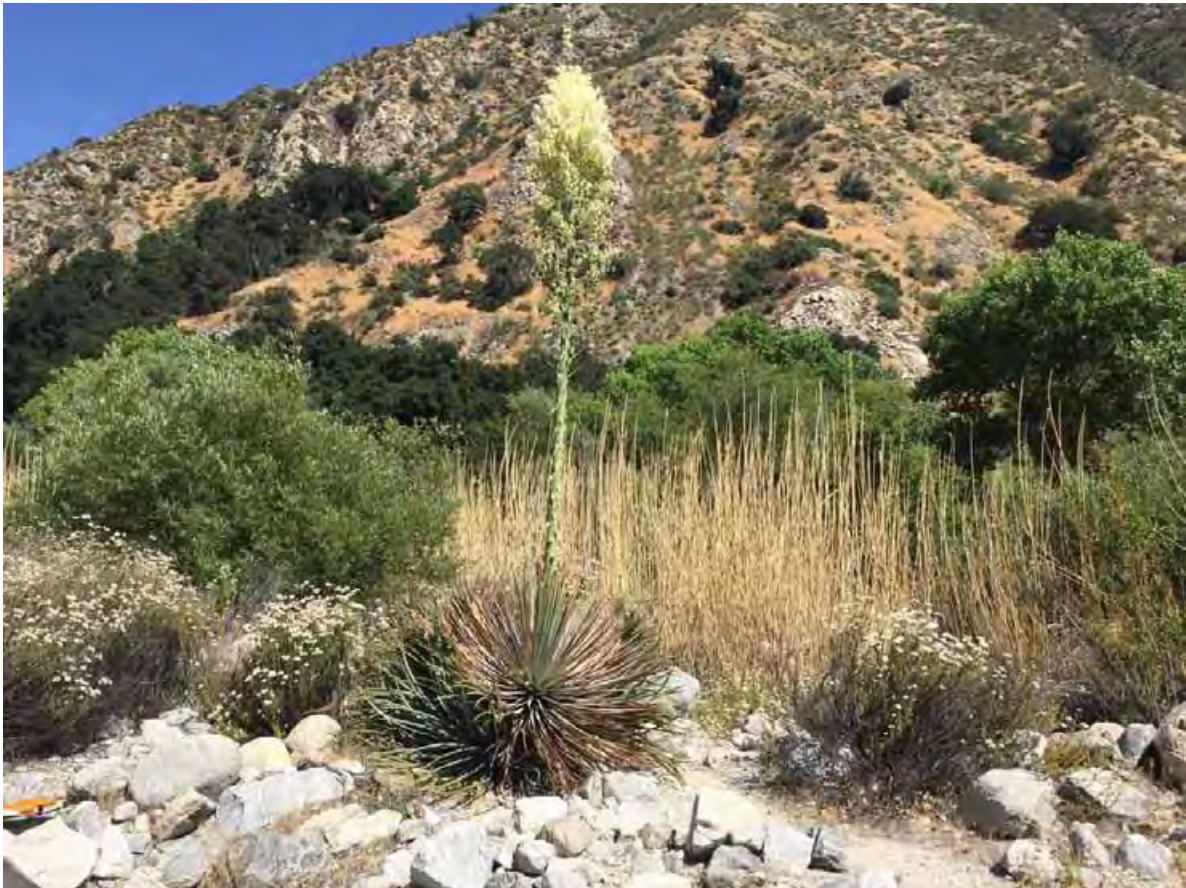
Photo point #7: National Forest Cabin, Big Tujunga: 2018-6-15 Minimal Arundo regrowth, second treatment will be in fall 2018.

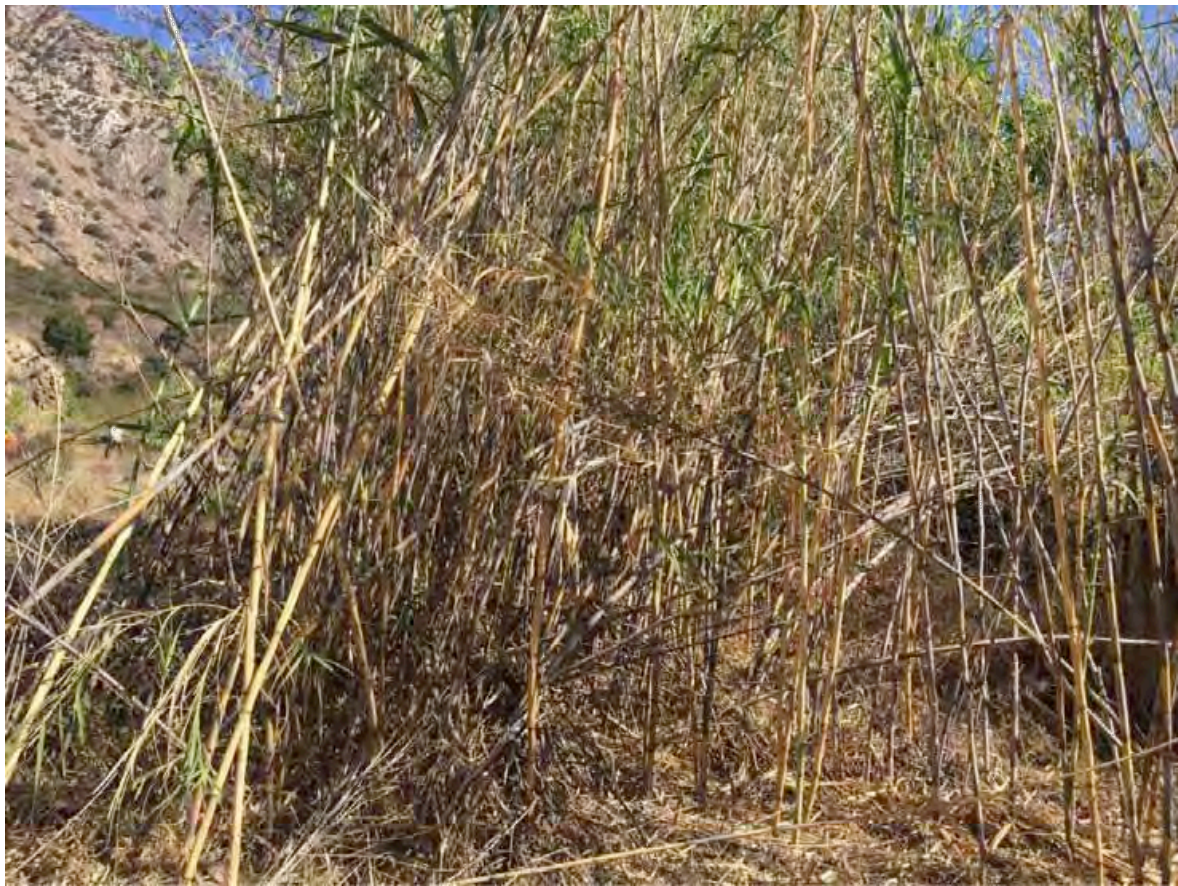
Photo point #8: National Forest Cabin, Big Tujunga: 2016-10-5 Arundo before cutting and chipping.

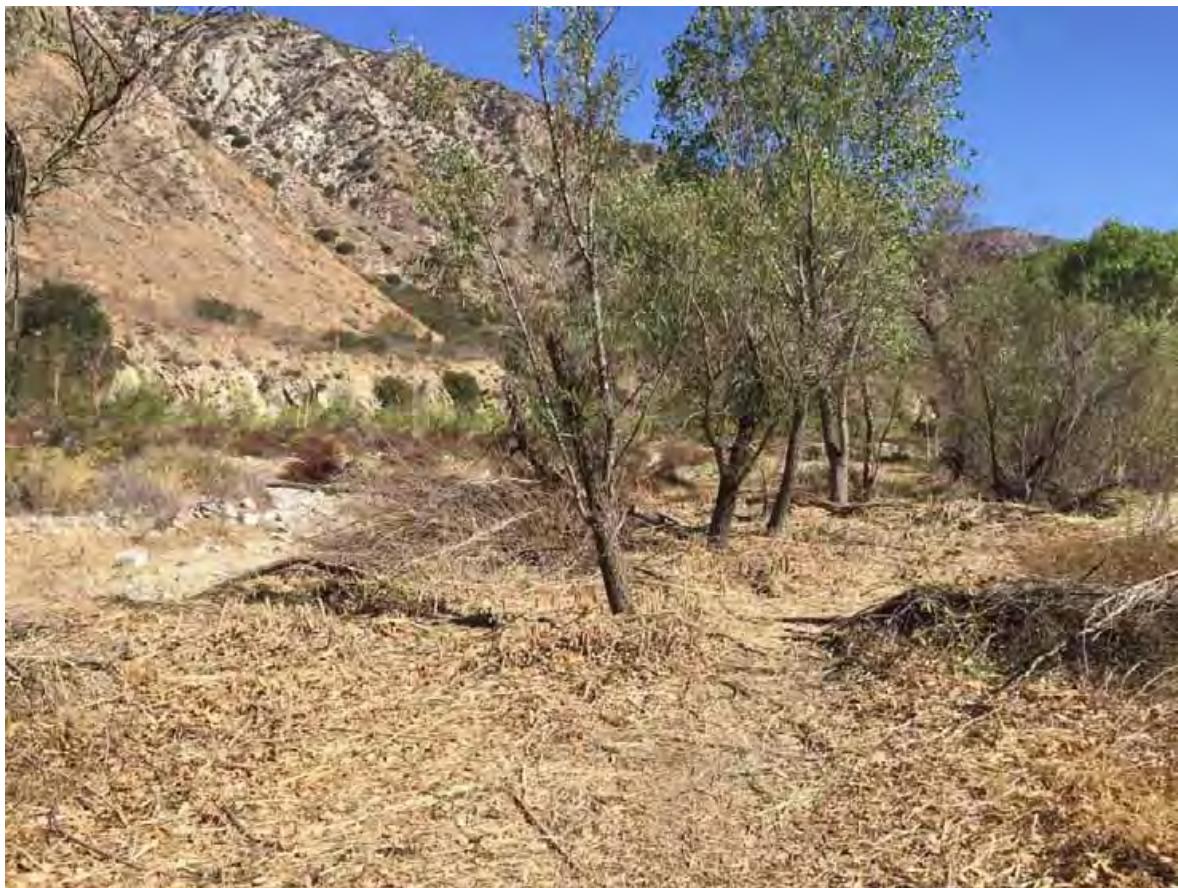
Photo point #8: National Forest Cabin, Big Tujunga: 2016-10-5 Arundo after cutting and chipping.
