Upper Los Angeles River Watershed Strategic Implementation Plan for *Arundo donax* Treatment and Eradication

PREPARED FOR
Council for Watershed Health
Los Angeles, California

PREPARED BY
Stillwater Sciences
555 W 5th Street, 35th Floor
Los Angeles, California 90013

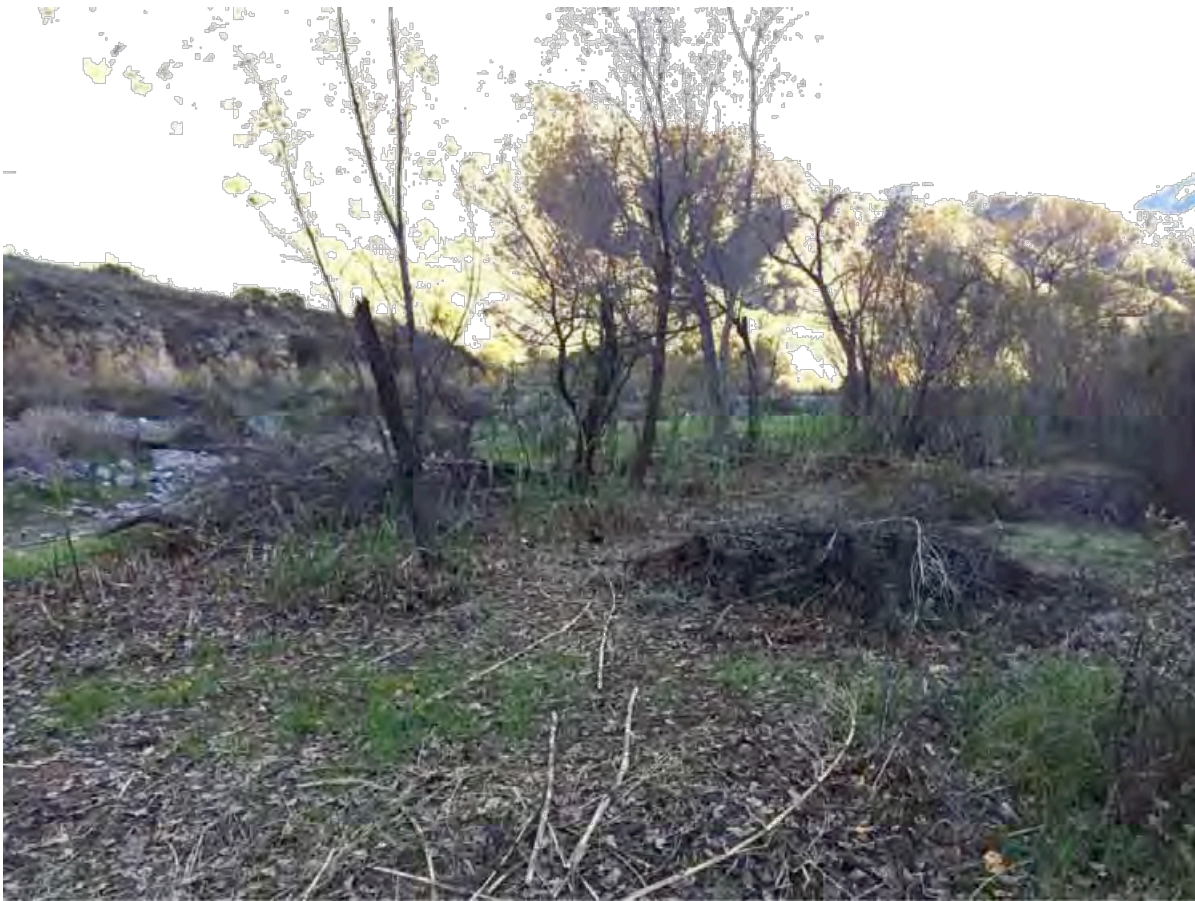
Photo point #8: National Forest Cabin, Big Tujunga: 2017-1-8 Arundo winter growth and first treatment.

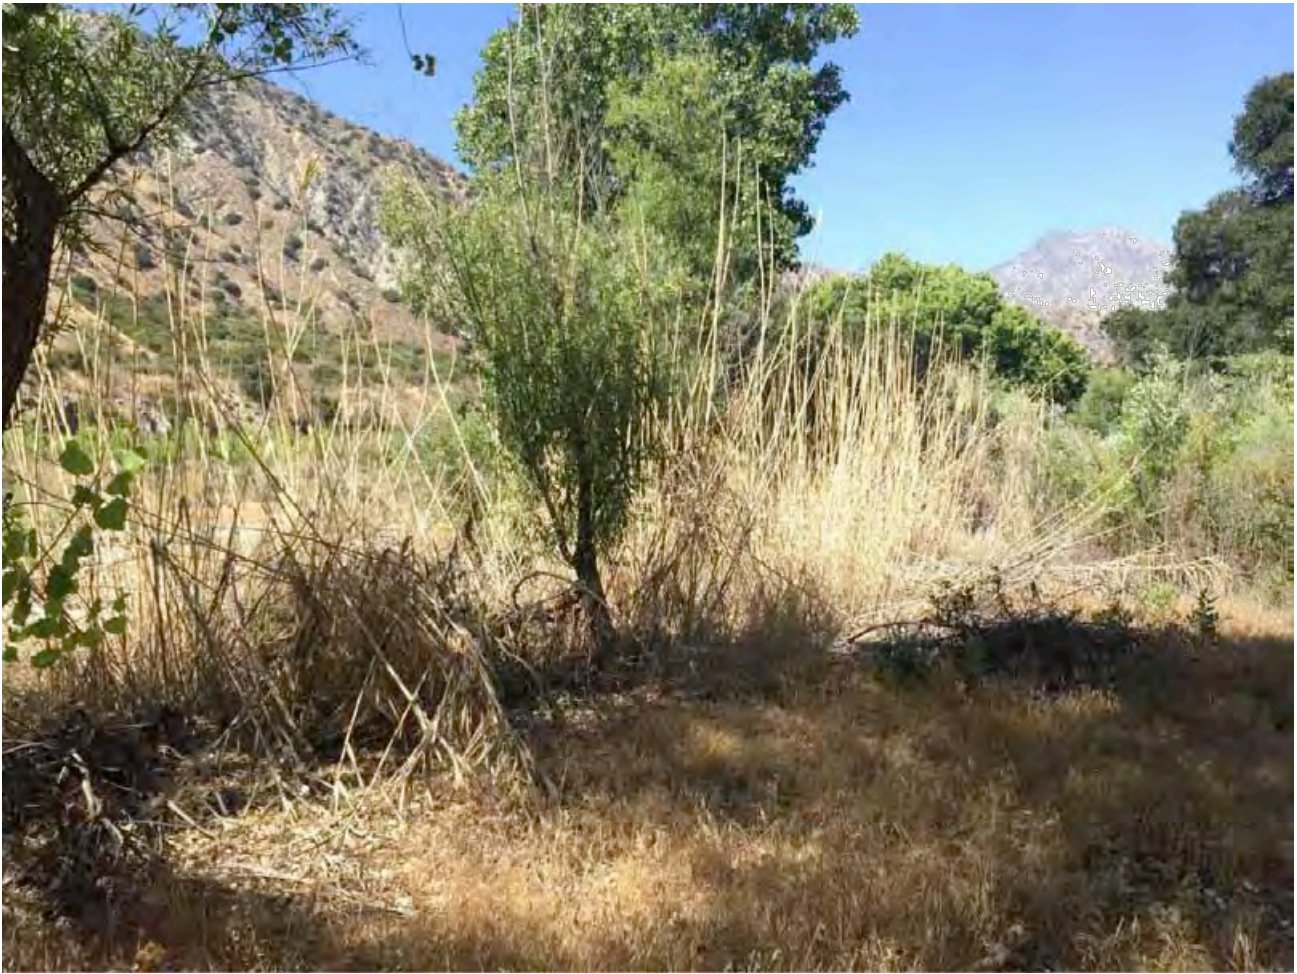
Photo point #8: National Forest Cabin, Big Tujunga: 2018-6-15 Minimal Arundo regrowth, second treatment will be in fall 2018.

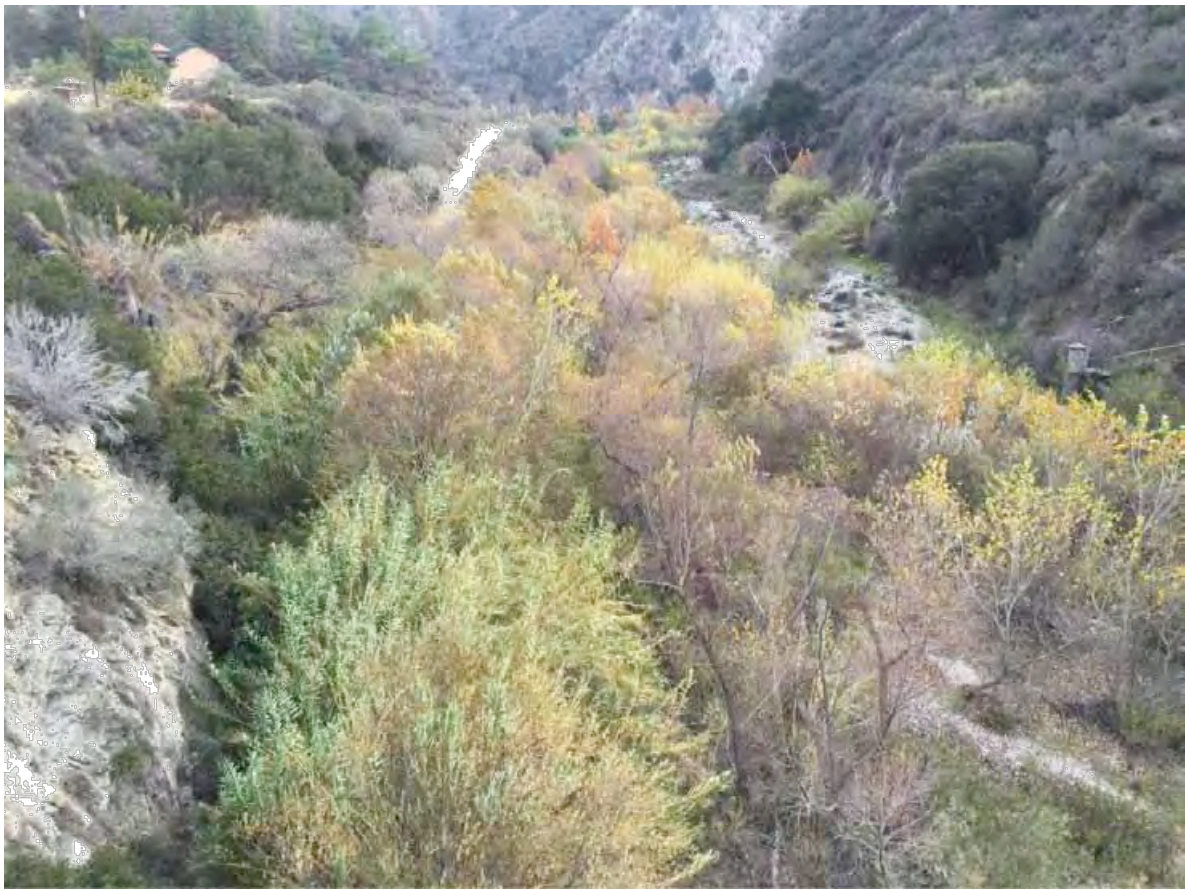
Photo point #9 Thundering Hooves, Big Tujunga: 2015-12-10 Arundo before cutting and chipping.

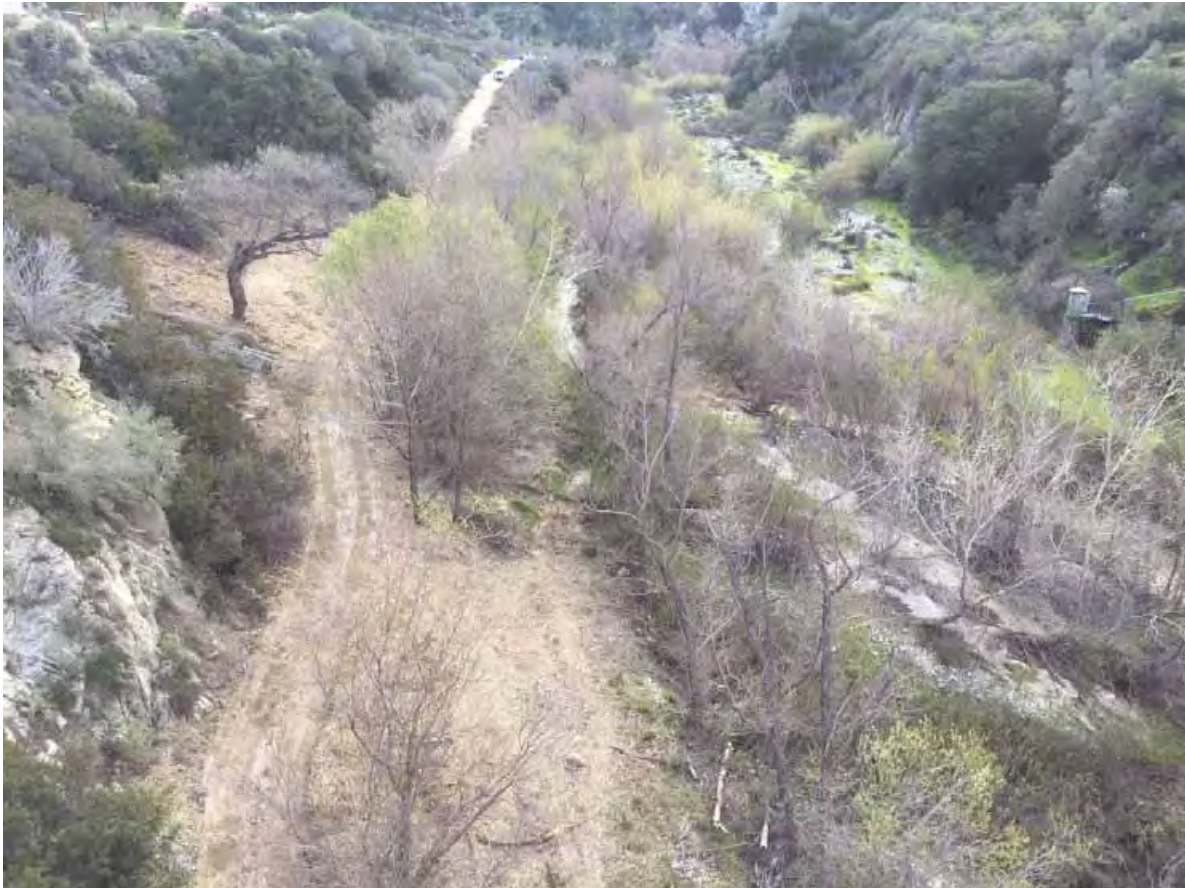
Photo point #9 Thundering Hooves, Big Tujunga: 2017-2-16 After cutting and chipping.

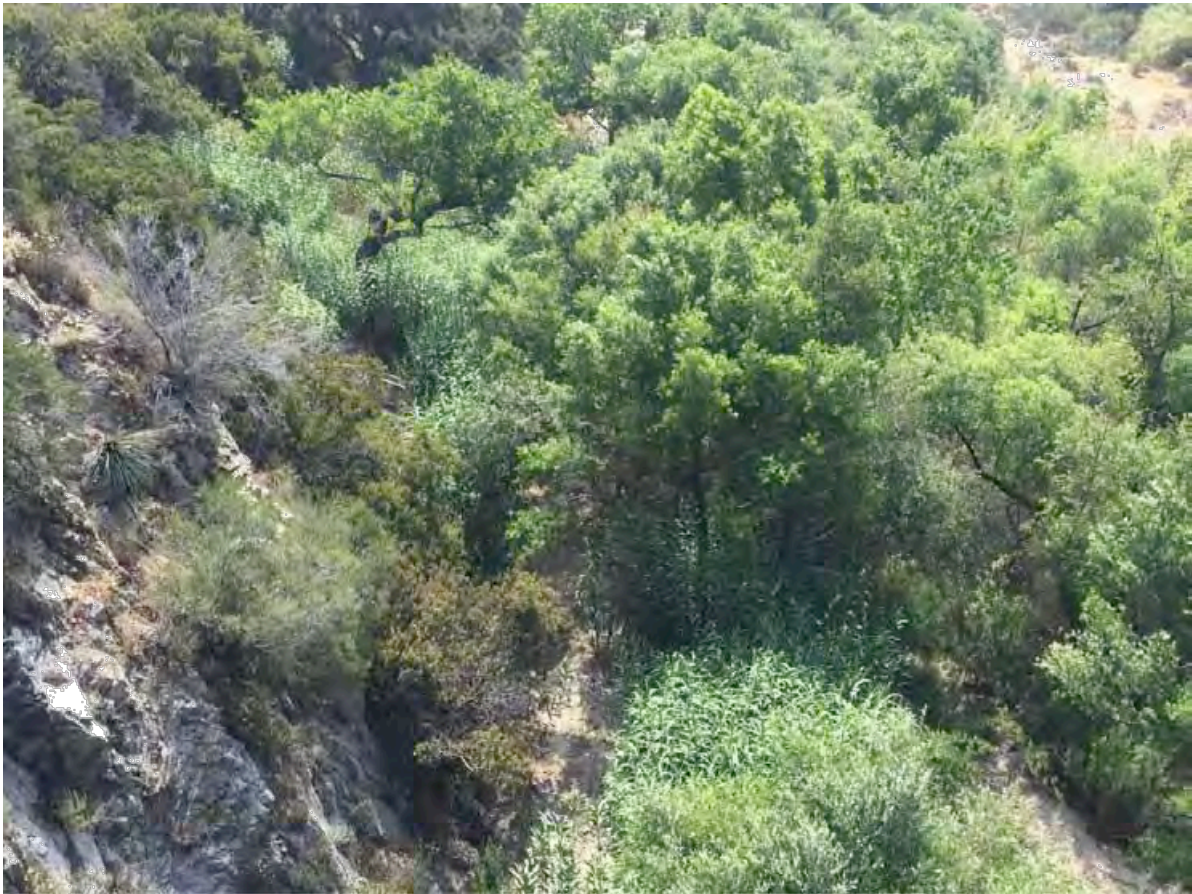
Photo point #9 Thundering Hooves, Big Tujunga: 2017-5-30 Arundo re-growth before first treatment.

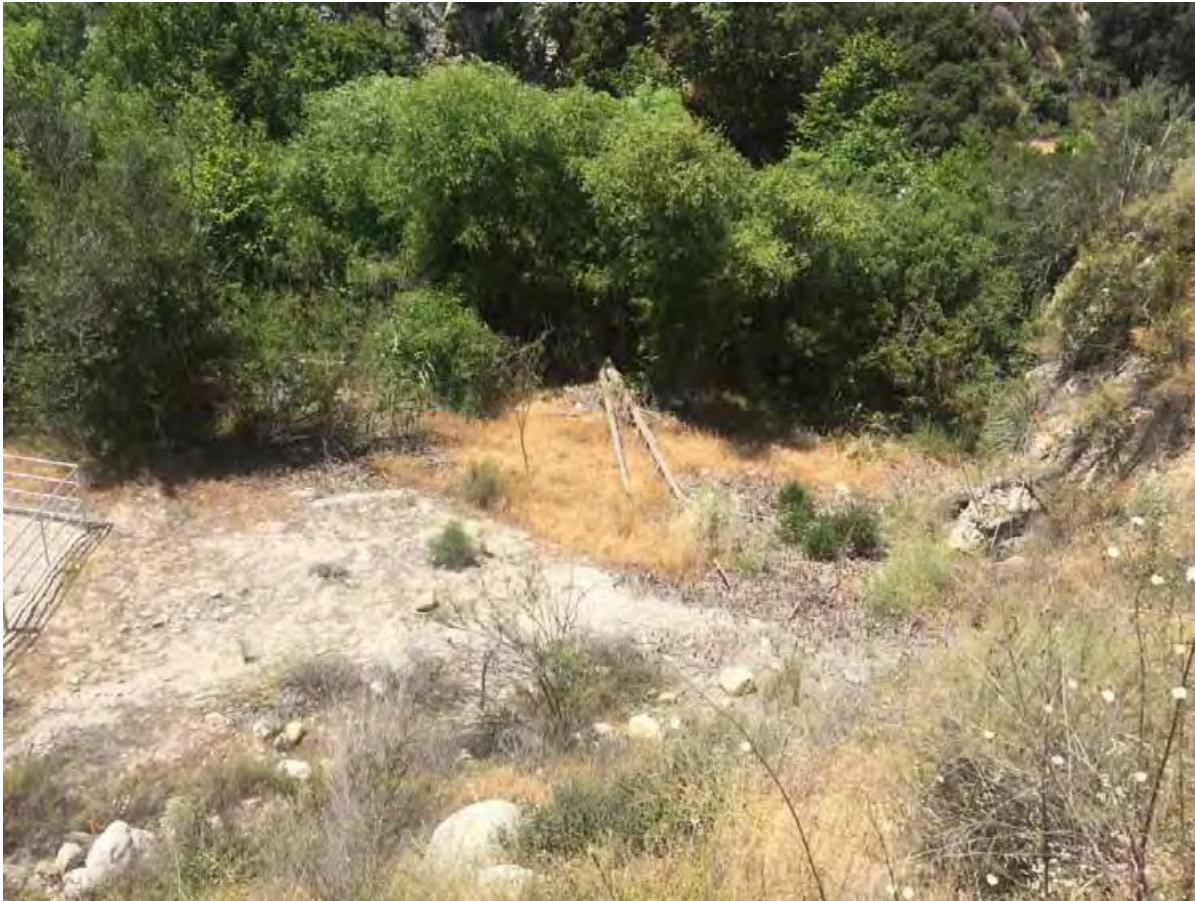
Photo point #9B Thundering Hooves, Big Tujunga: 2018-6-15 Minimal regrowth, about to have second treatment.

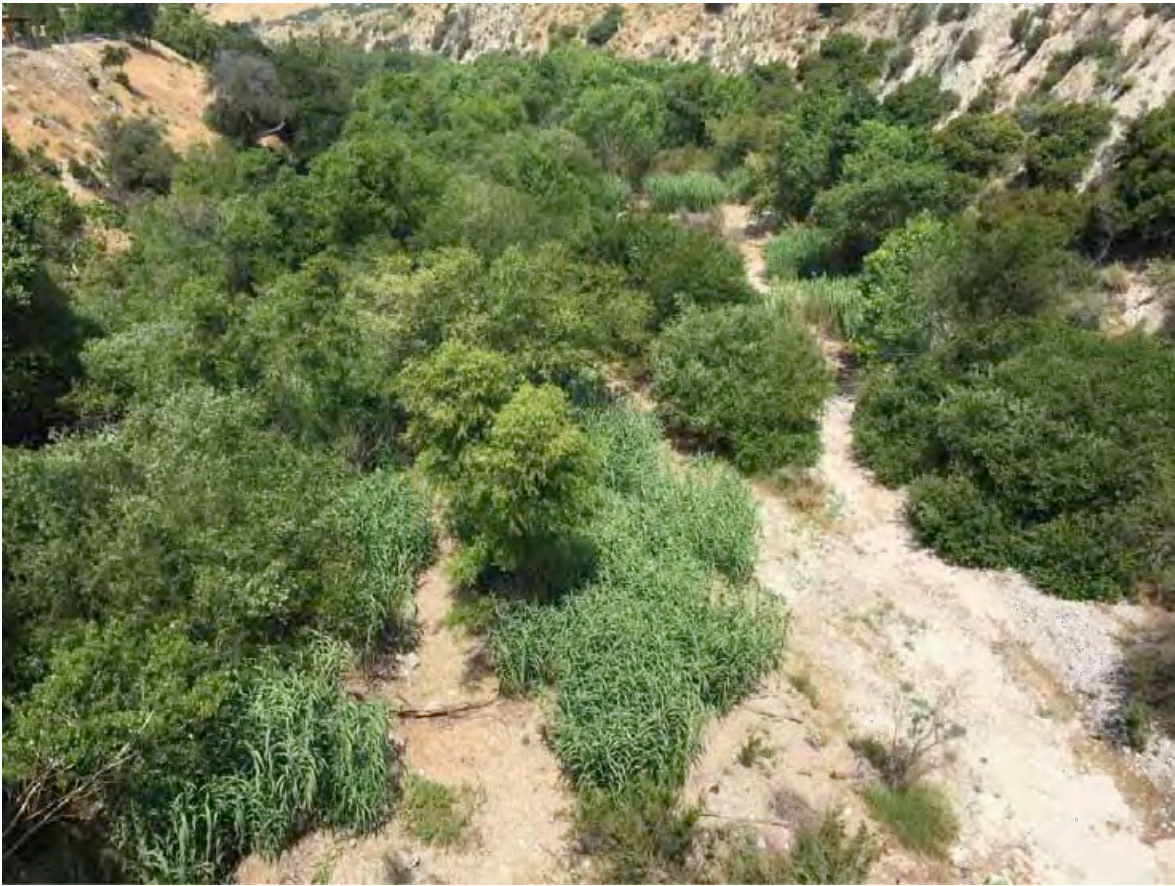
Photo point #10: Gorge, Big Tujunga: 2017-5-30 Arundo spring re-growth before first treatment.

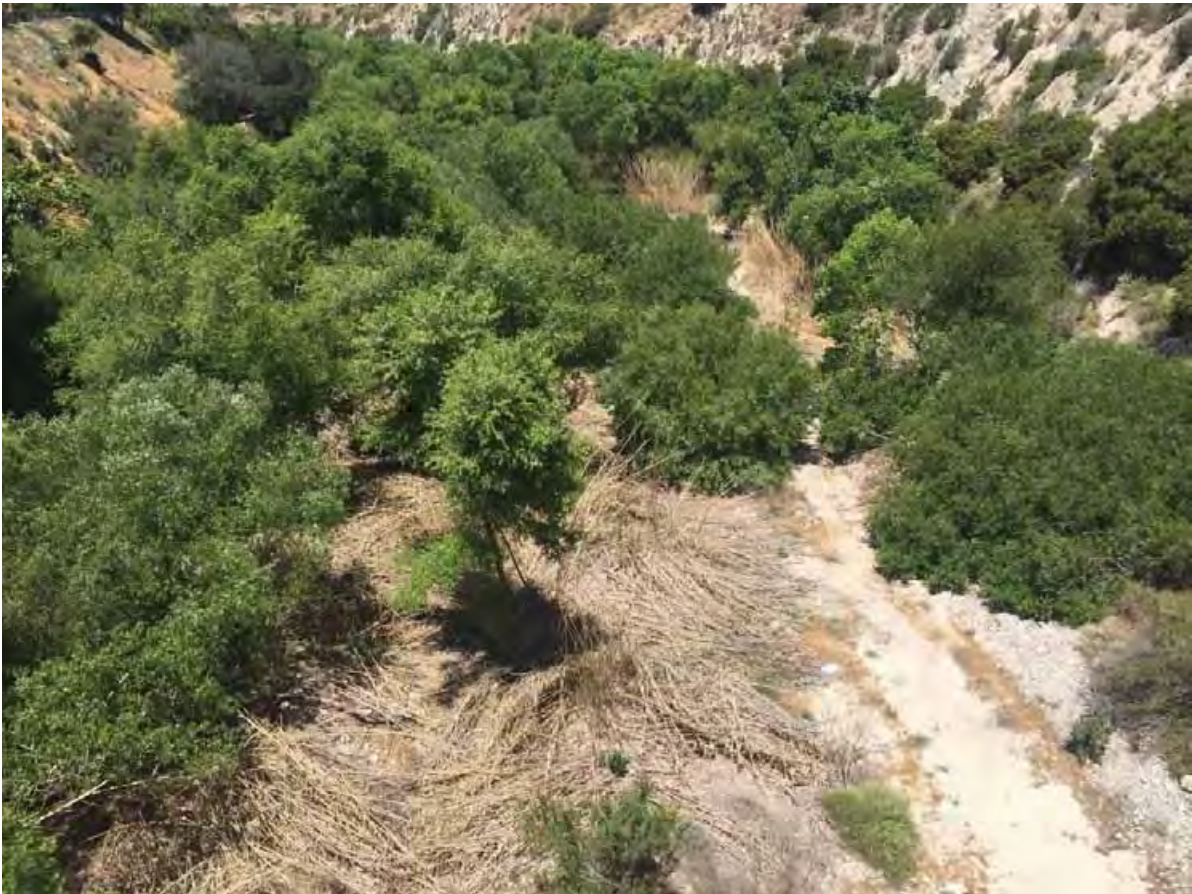
Photo point #10: Gorge, Big Tujunga: 2018-6-15 Minimal Arundo regrowth, about to have second treatment.

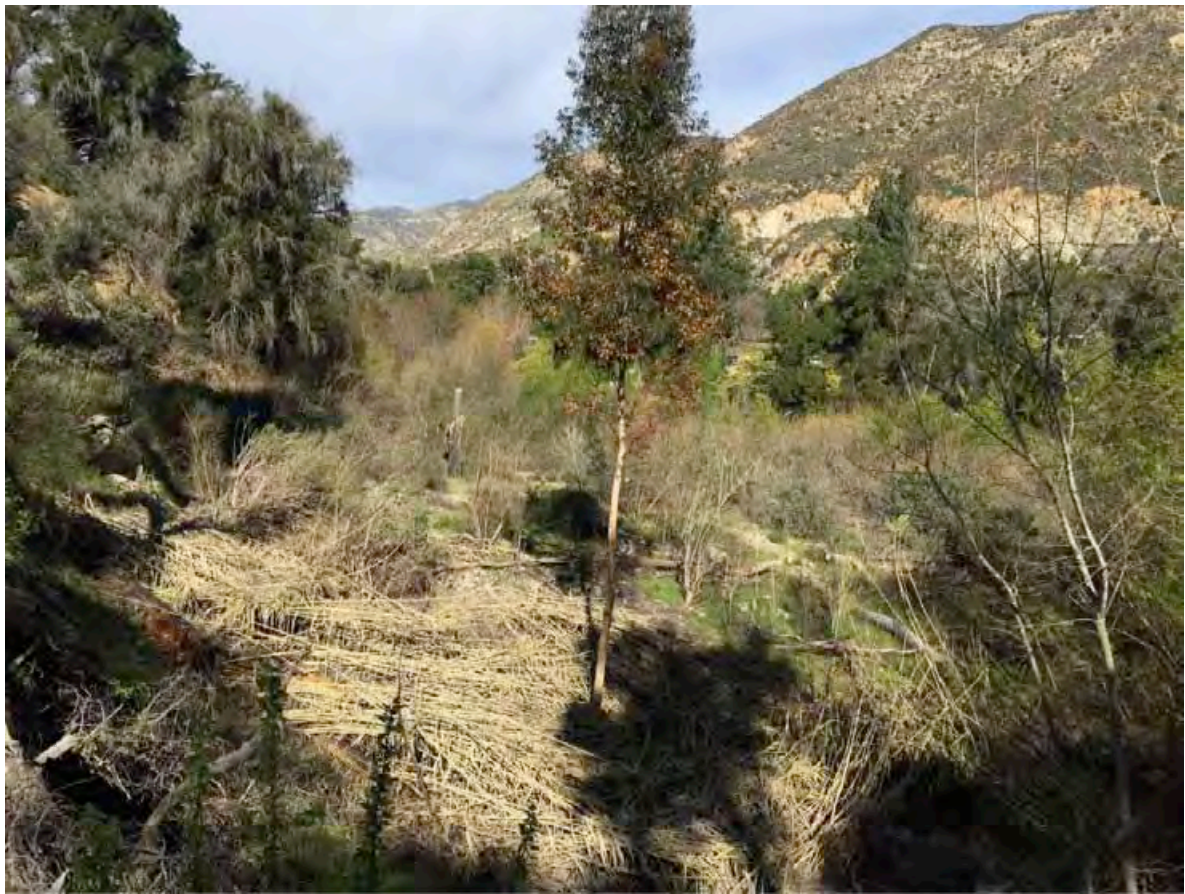
Photo Point #11 Vogel Flat, Big Tujunga: 2017-2-16 Arundo re-growth after first treatment in fall 2015.

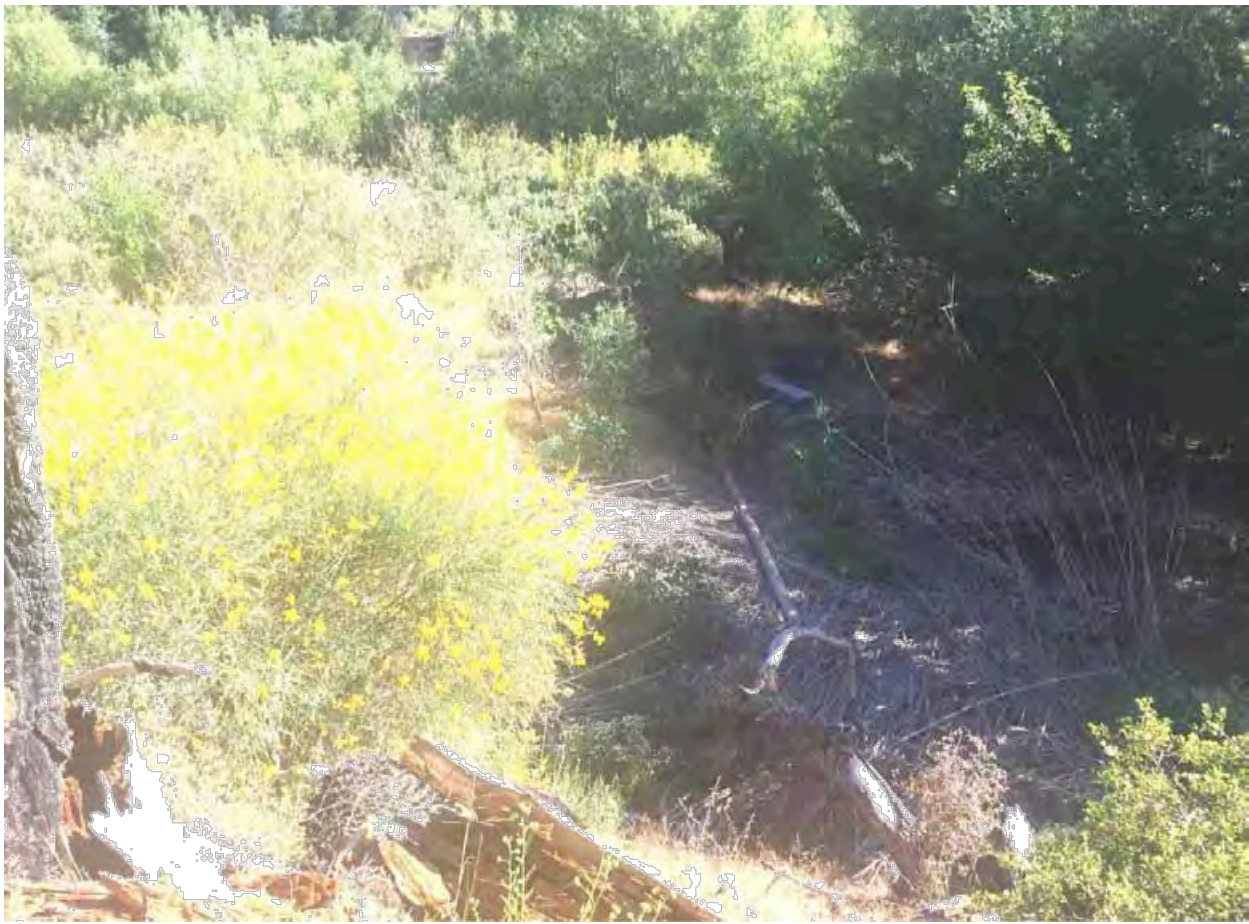
Photo Point #11 Vogel Flat, Big Tujunga: 2018-6-15 Minimal *Arundo* regrowth, second treatment will be in fall 2018.

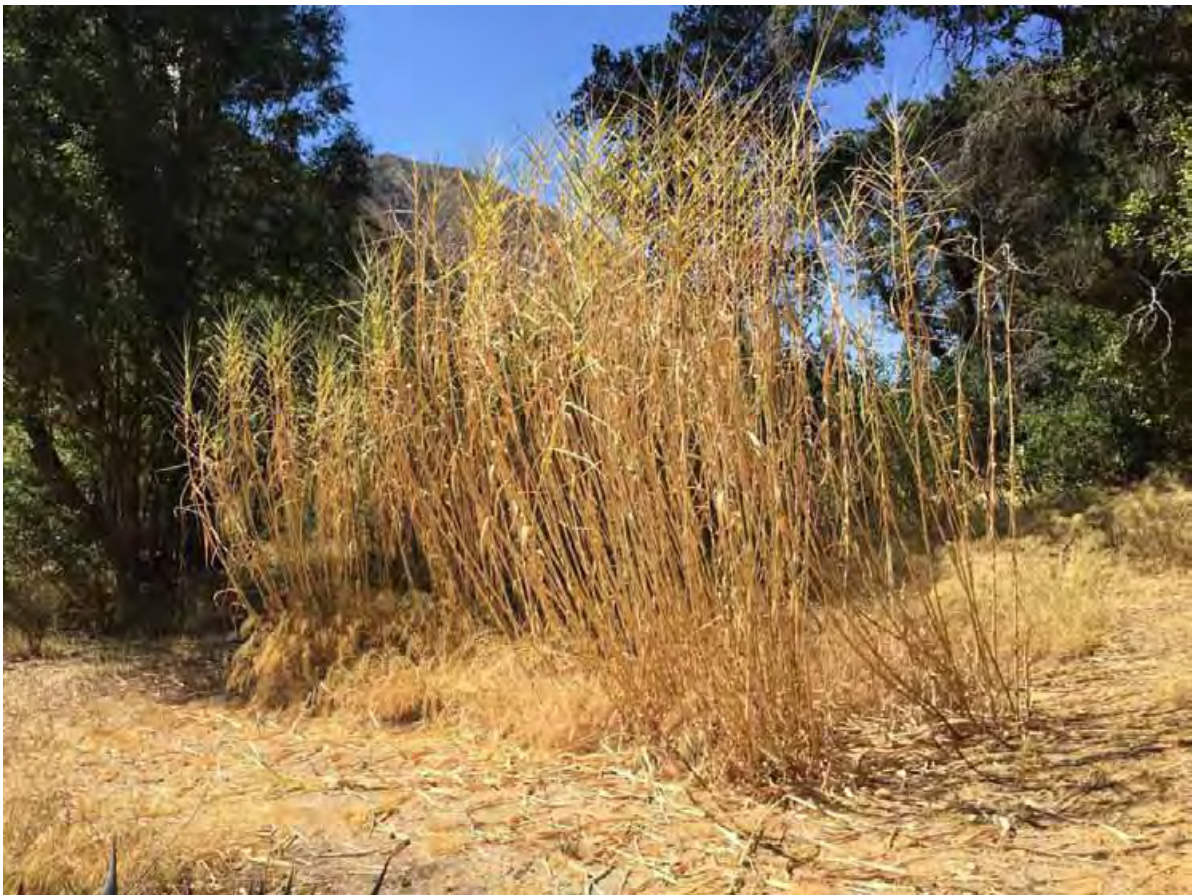
Photo point #12: Vogel Flat Cabin, Big Tujunga: 2016-9-26 Arundo re-growth after first spring treatment.

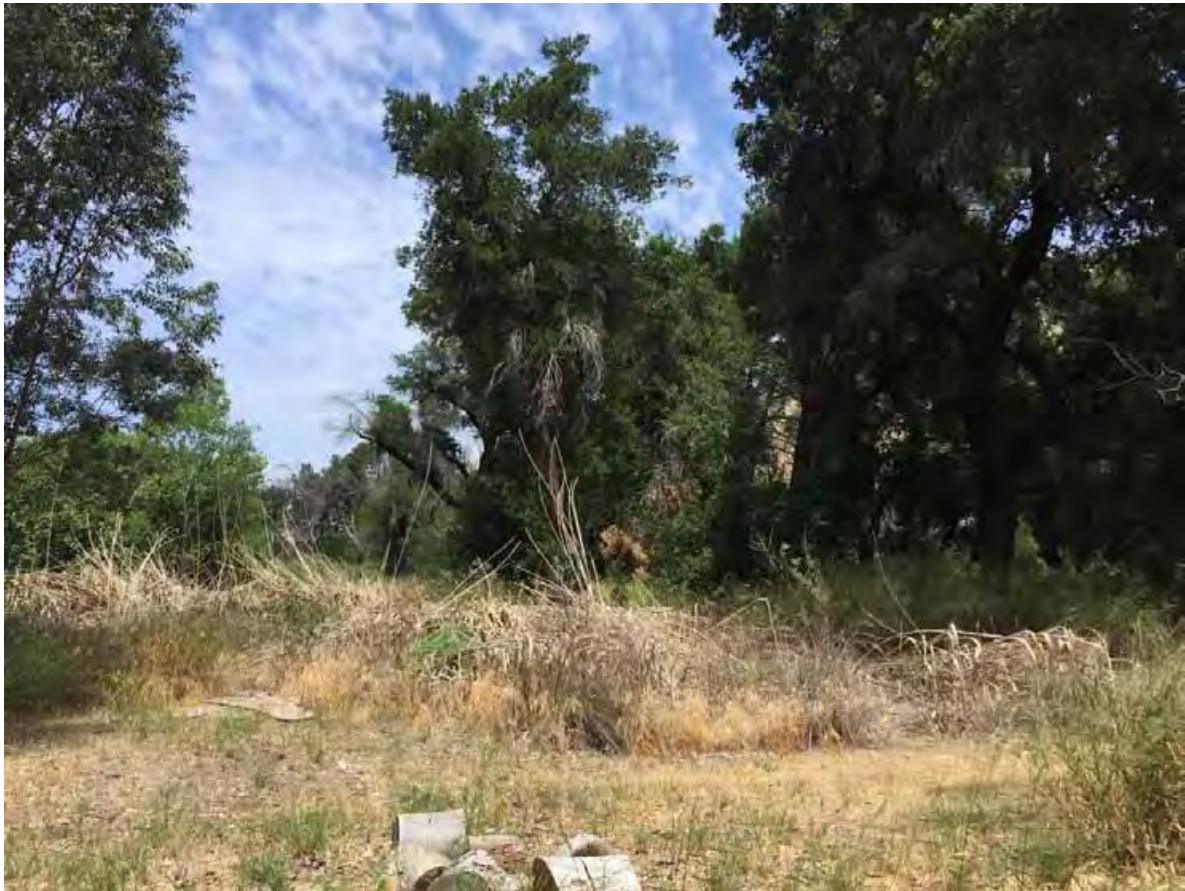
Photo point #12: Vogel Flat Cabin, Big Tujunga: 2017-5-30 Arundo stand with no re-growth.

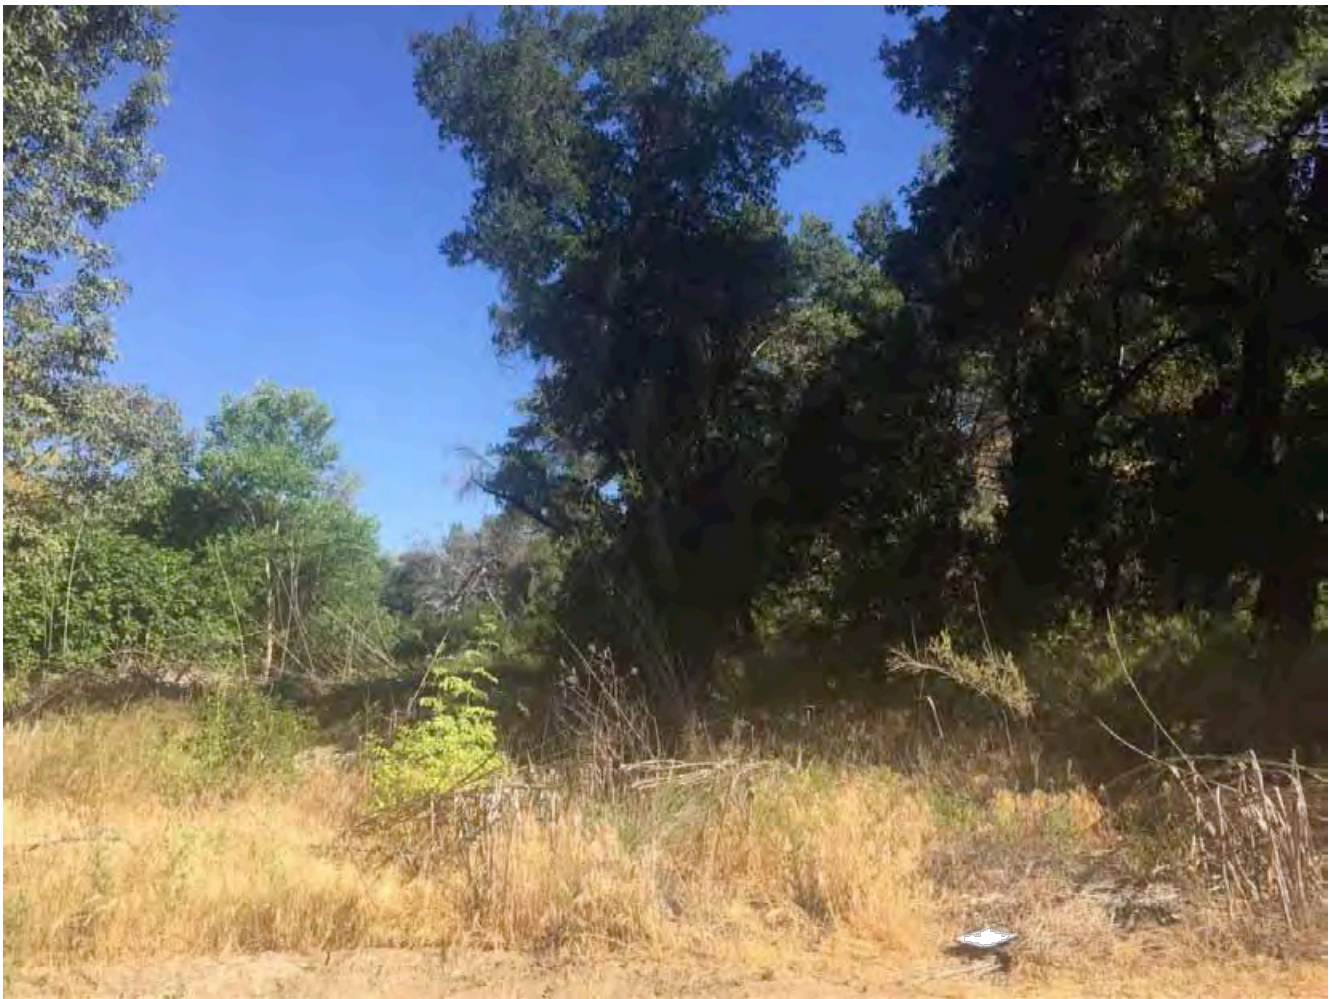
Photo point #12: Vogel Flat Cabin, Big Tujunga: 2018-6-15 Minimal Arundo regrowth, second treatment will be in fall 2018.

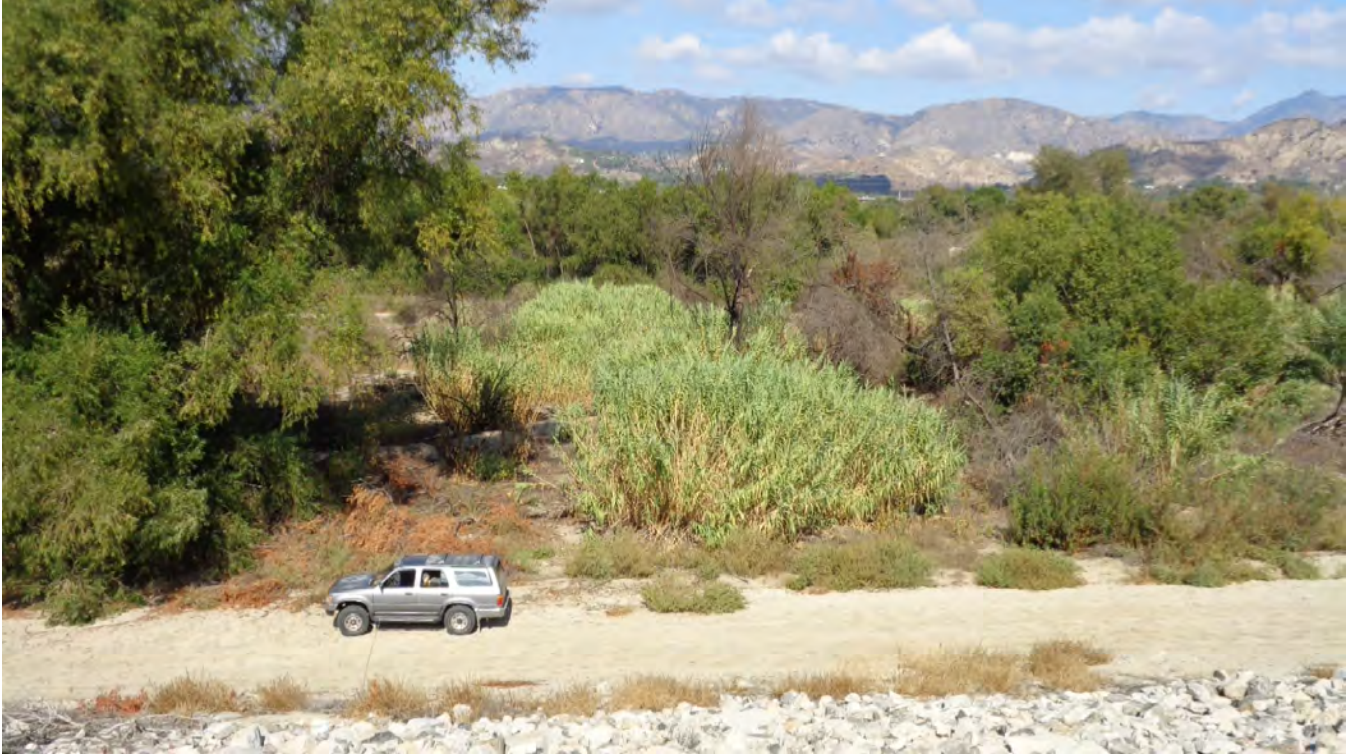
I have taken photos of some areas to document future progress of herbicide treatments. The attached photo, taken from the dam, shows the "southeast burn area" that I described in my report of October 17.

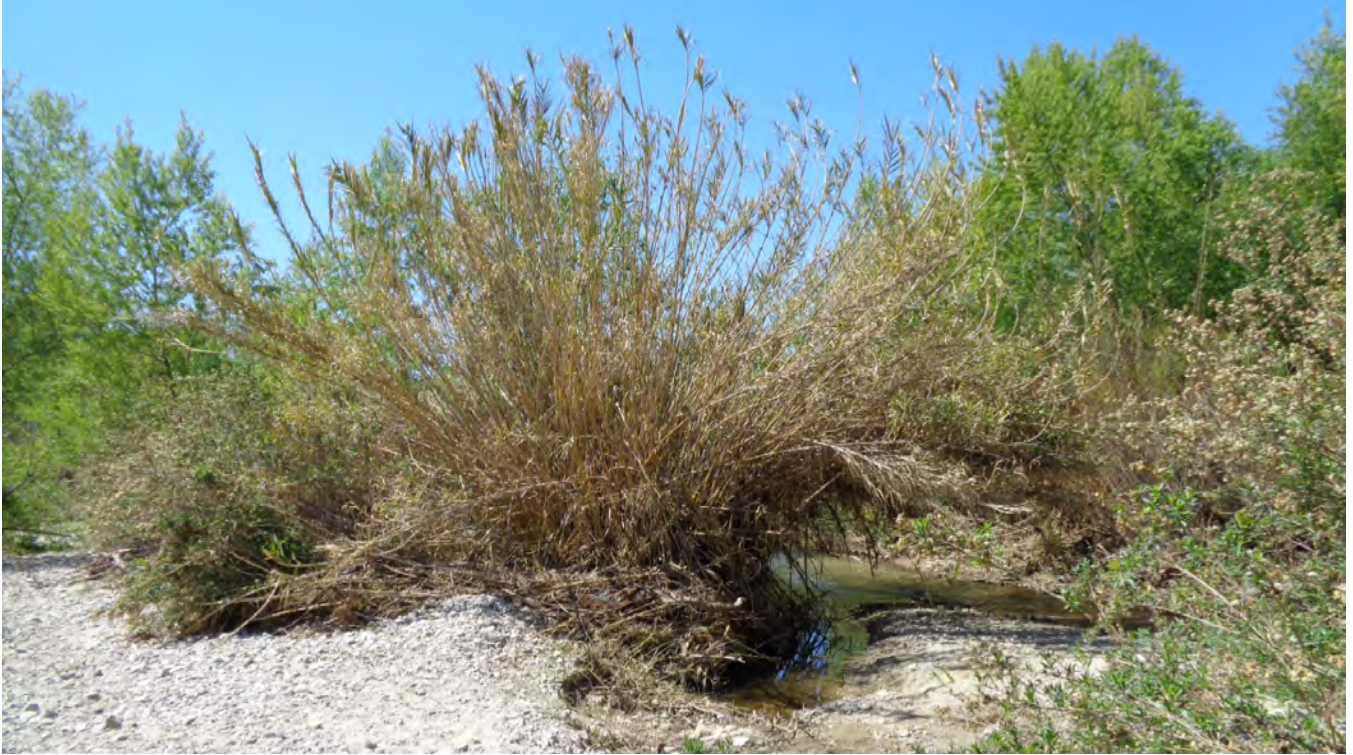
Photo 6 (17.43.36): On the upland terrace near the southeast burn area, small clumps are dependent on rainwater so are drought-stressed during summer months with growth limited to about 16 feet. The clump on the left may have been mostly dormant last fall, so presumably was not sprayed and is now resprouting; whereas the dead clump on the right probably had some green foliage last fall that was sprayed.

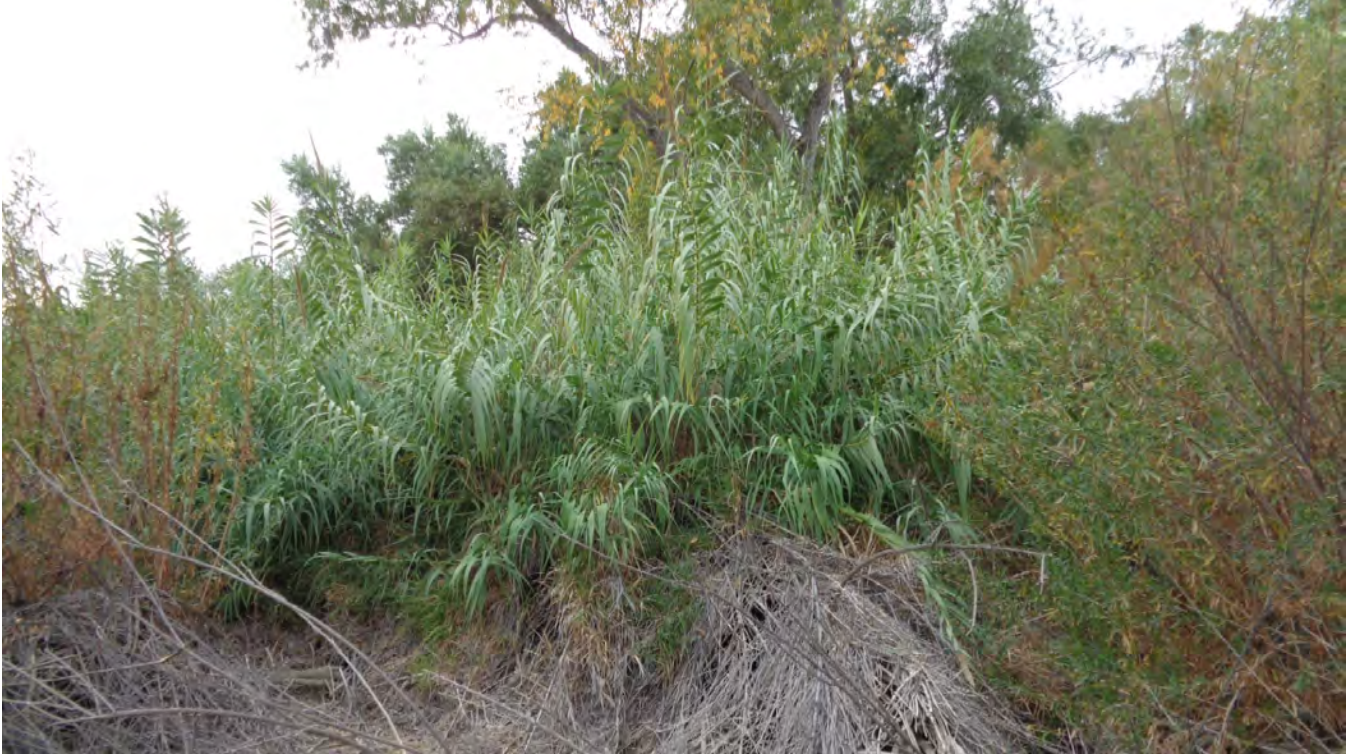
The fifth and last photo (15.34.56) shows previously untreated upland Arundo near the fourth location but at slightly lower elevation, where soil moisture and native trees are more abundant.
